DOGGER BANK D WIND FARM

Appendix 24.4 Onshore Heritage Walkover Report

Document Reference No: 2.24.4

Date: June 2025

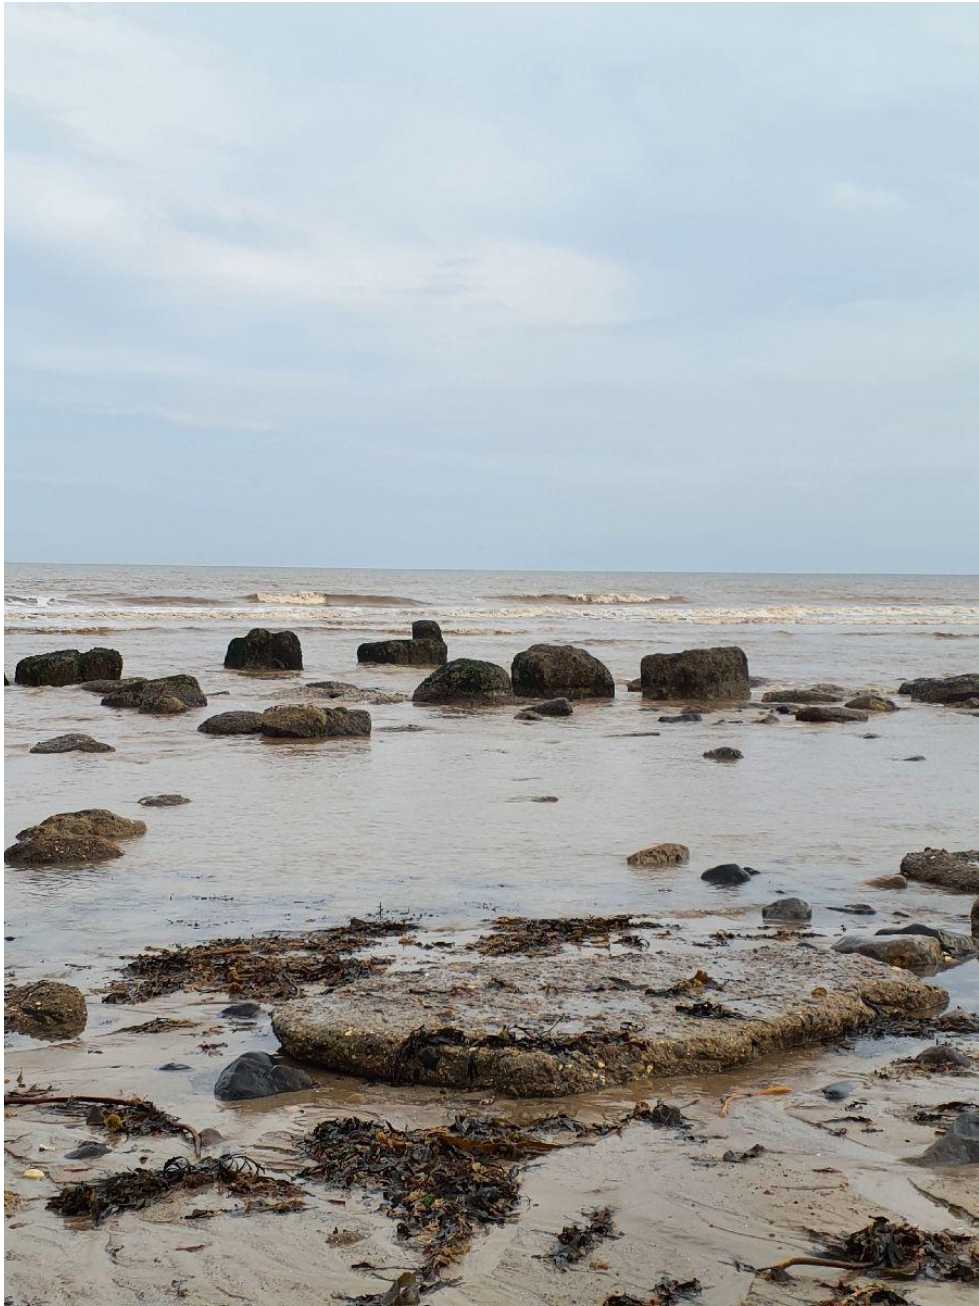
16. Due to the extent of erosion along the coast, and the positioning of former clifftop structures now observed on the beach, several of the structures could not be attributed to their specific corresponding record in the Humber HER with exact certainty. **Plate 24.4-1**, shows a number of structures which suggest the possibility of these corresponding to the beach defences noted within record MHU21244, however, some of the squarer structures may also be the remains of anti-tank cubes (MHU21234).

Plate 24.4-1 Military Structures Visible on the Beach, Photographed Facing East Towards the Sea.

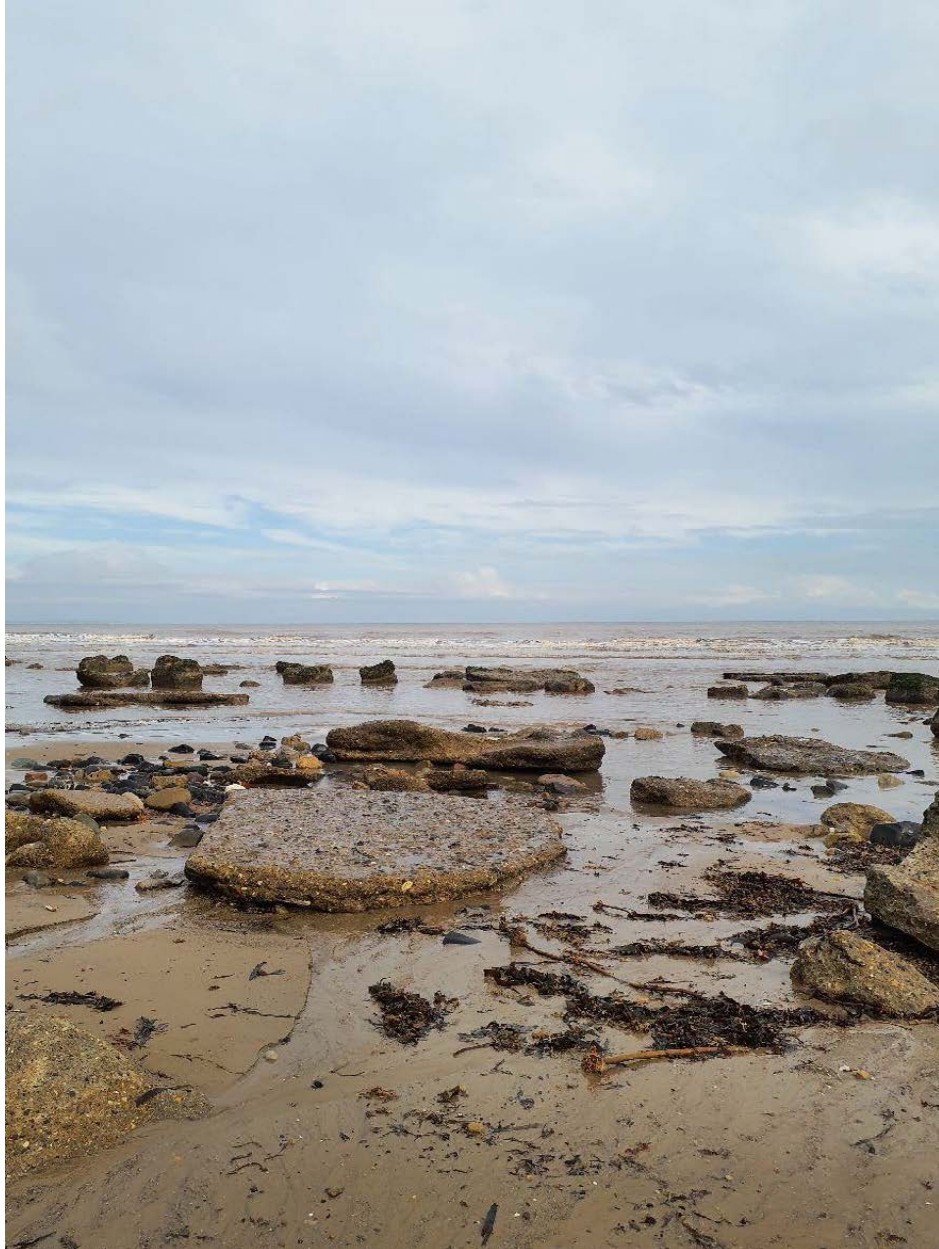
17. The surviving remains of WWII Pillbox MHU21242 are also mapped in proximity to the beach defences and anti-tank cubes. The only extant remains of the pillbox, as is noted in the Humber HER, is its roof. Due to the extent of concrete remains along this section of the coastline, it is unclear which extant remains may correspond to the surviving roof of this pillbox, though the flat concrete structures shown in **Plate 24.4-1** and **Plate 24.4-2** likely correspond to this asset.

Plate 24.4-2 Further Remains of Military Defence Structures Including Possible Roof of WWII Pillbox (MHU21242) Photographed Facing East Towards the Sea

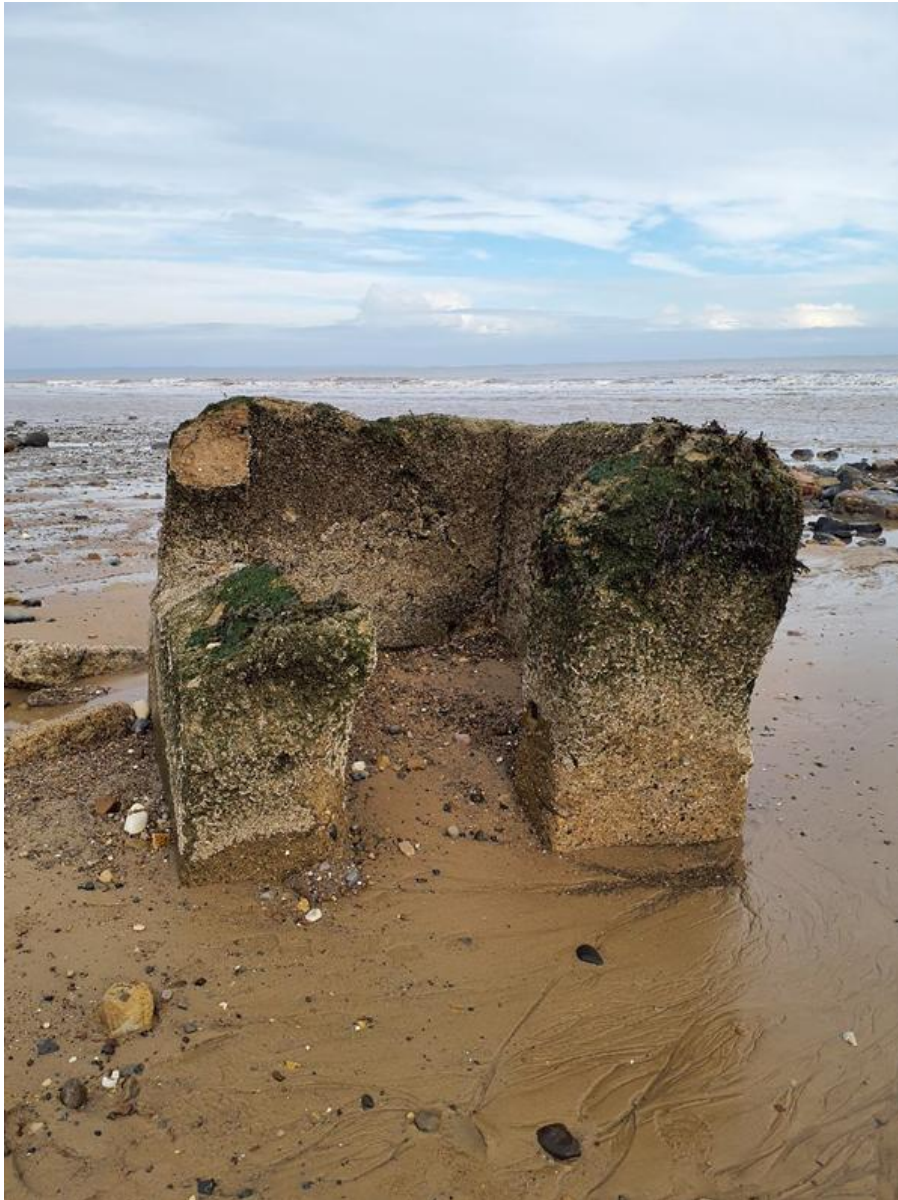
18. Despite some of the coastal assets being unidentifiable due to their degraded condition and dislocation, some individual records can be more accurately attributed to their records. **Plate 24.4-3** shows the visible remains of the modern-dated pillbox recorded within the Humber HER as MHU21224.
19. As is noted within the Humber HER record description taken from the 2010 Rapid Coastal Zone Assessment Survey conducted by English Heritage (English Heritage, 2010), the remains are now present on the beach due to the coastal erosion along the Holderness Coast.

Plate 24.4-3 Remains of Pillbox (MHU21224) on Beach, Photographed Facing East.

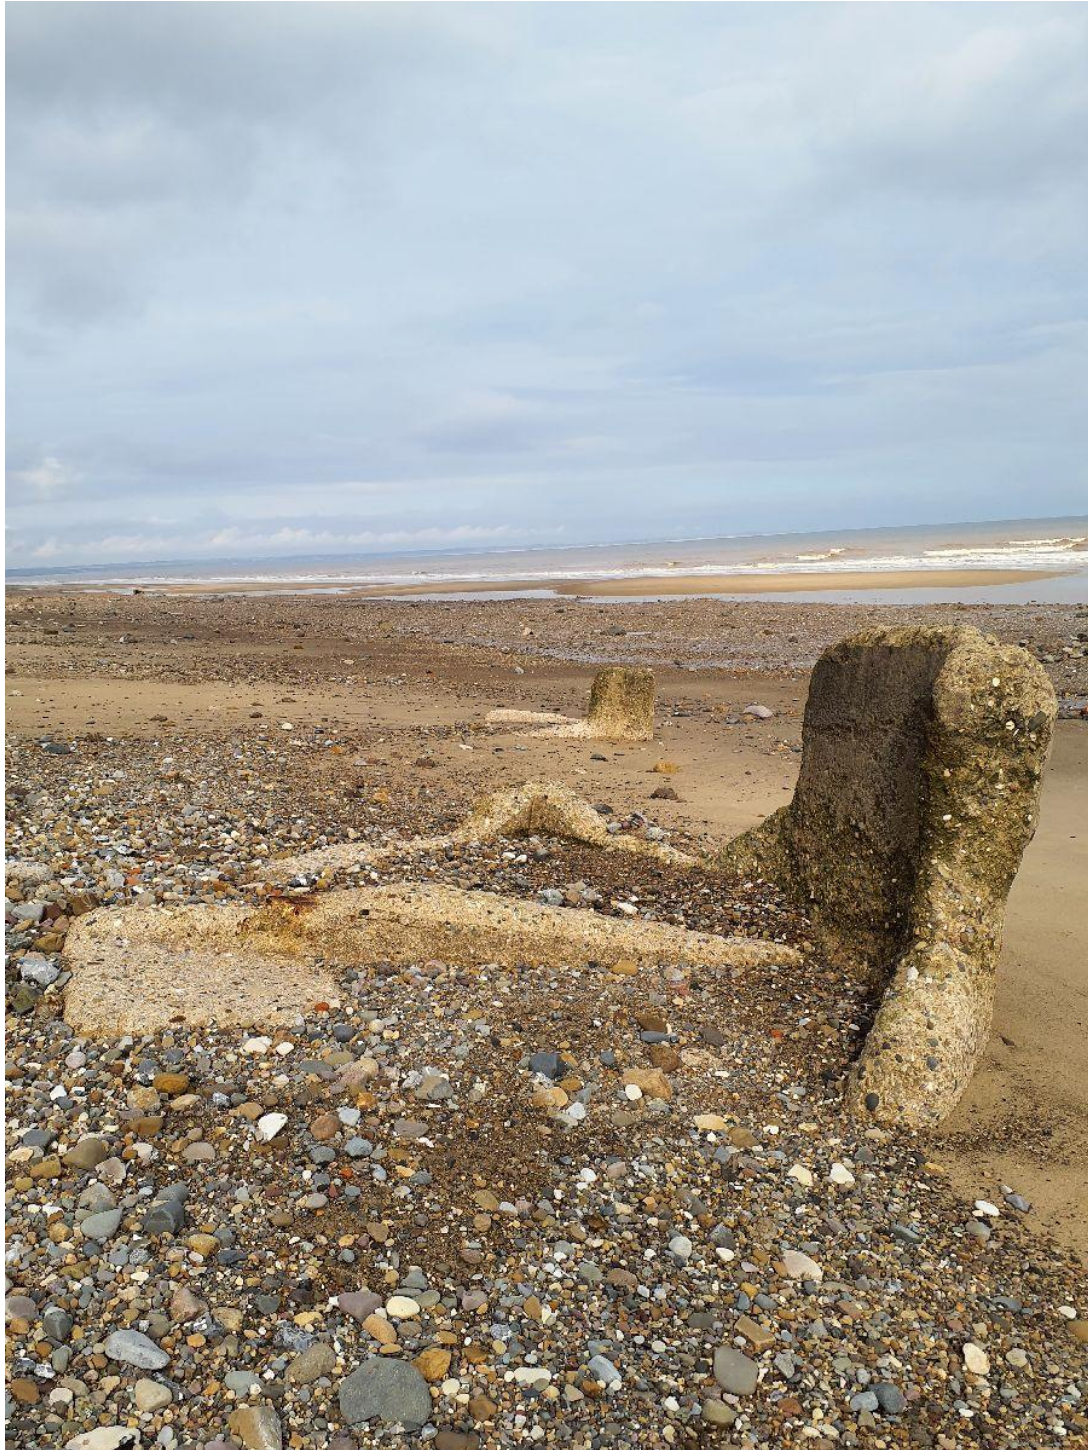
20. The weathered remains of pillbox MHU21233 were recorded on the beach with its eared design, specific to the north-east, still visible despite its heavily eroded condition (**Plate 24.4-4**).

Plate 24.4-4 Remains of Eared Pillbox (MHU21233) on Beach, Photographed Facing North.

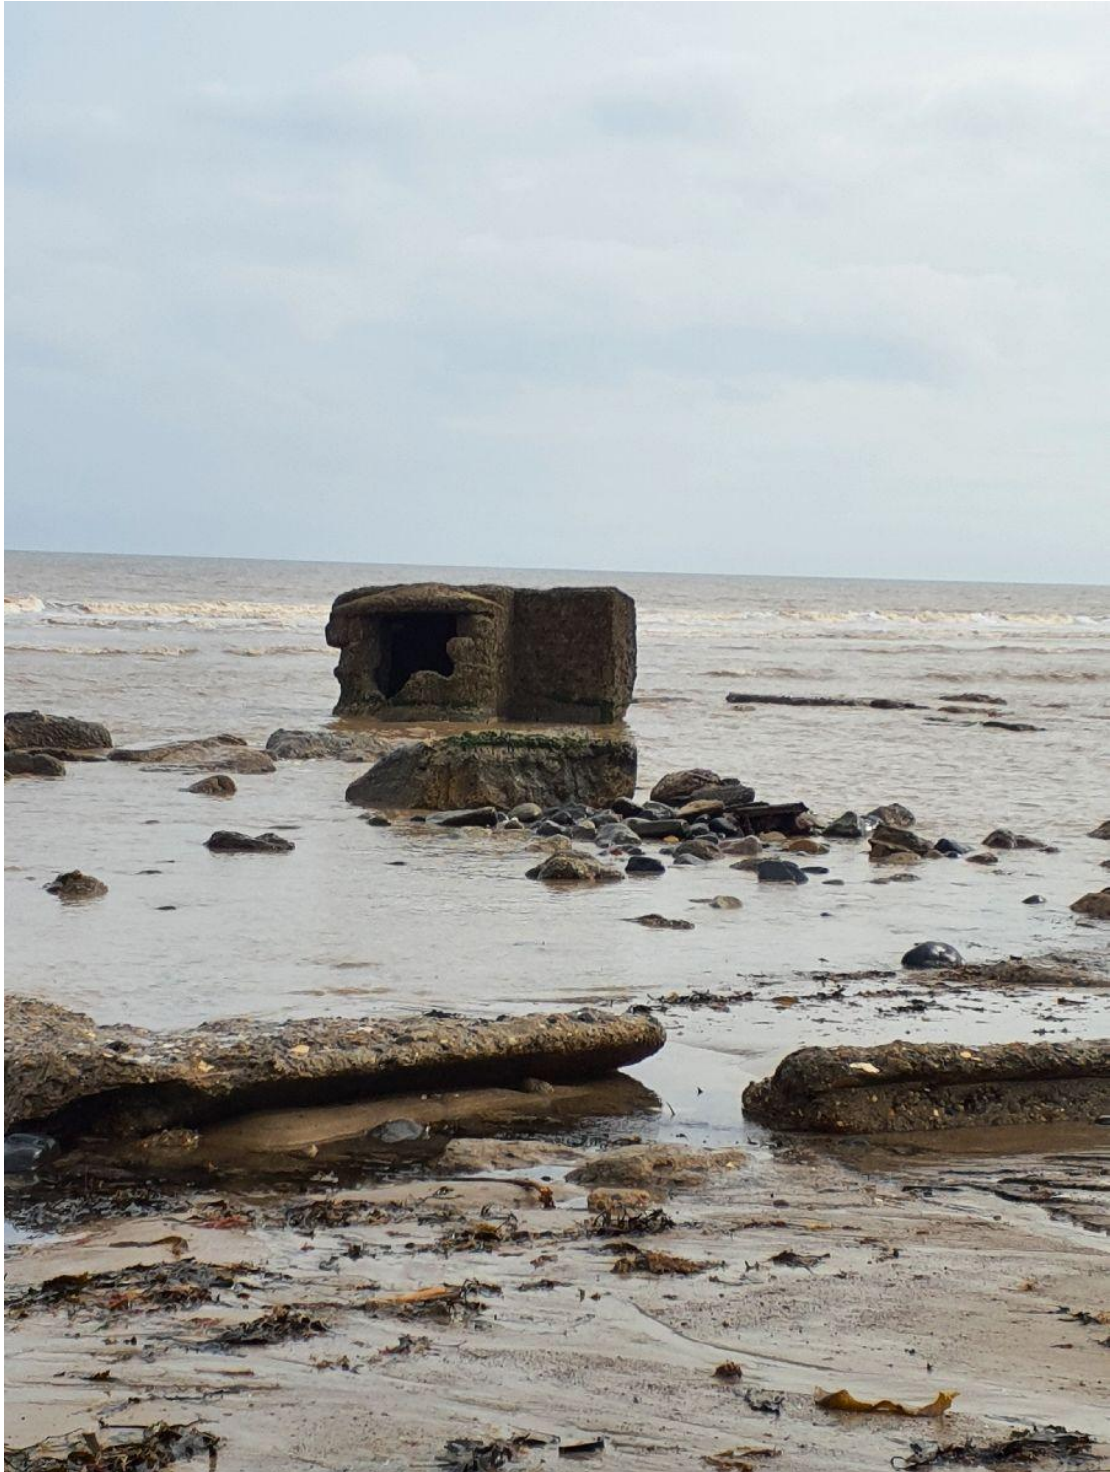
21. Due to the shape of the structure and proximity to the record mapped within the HER, it is presumed that the weathered remains pictured in **Plate 24.4-5** correspond to record MHU21235, the WWII beach defence light.

Plate 24.4-5 Remains of WWII Beach Defence Light (MHU21235) Photographed Facing East.

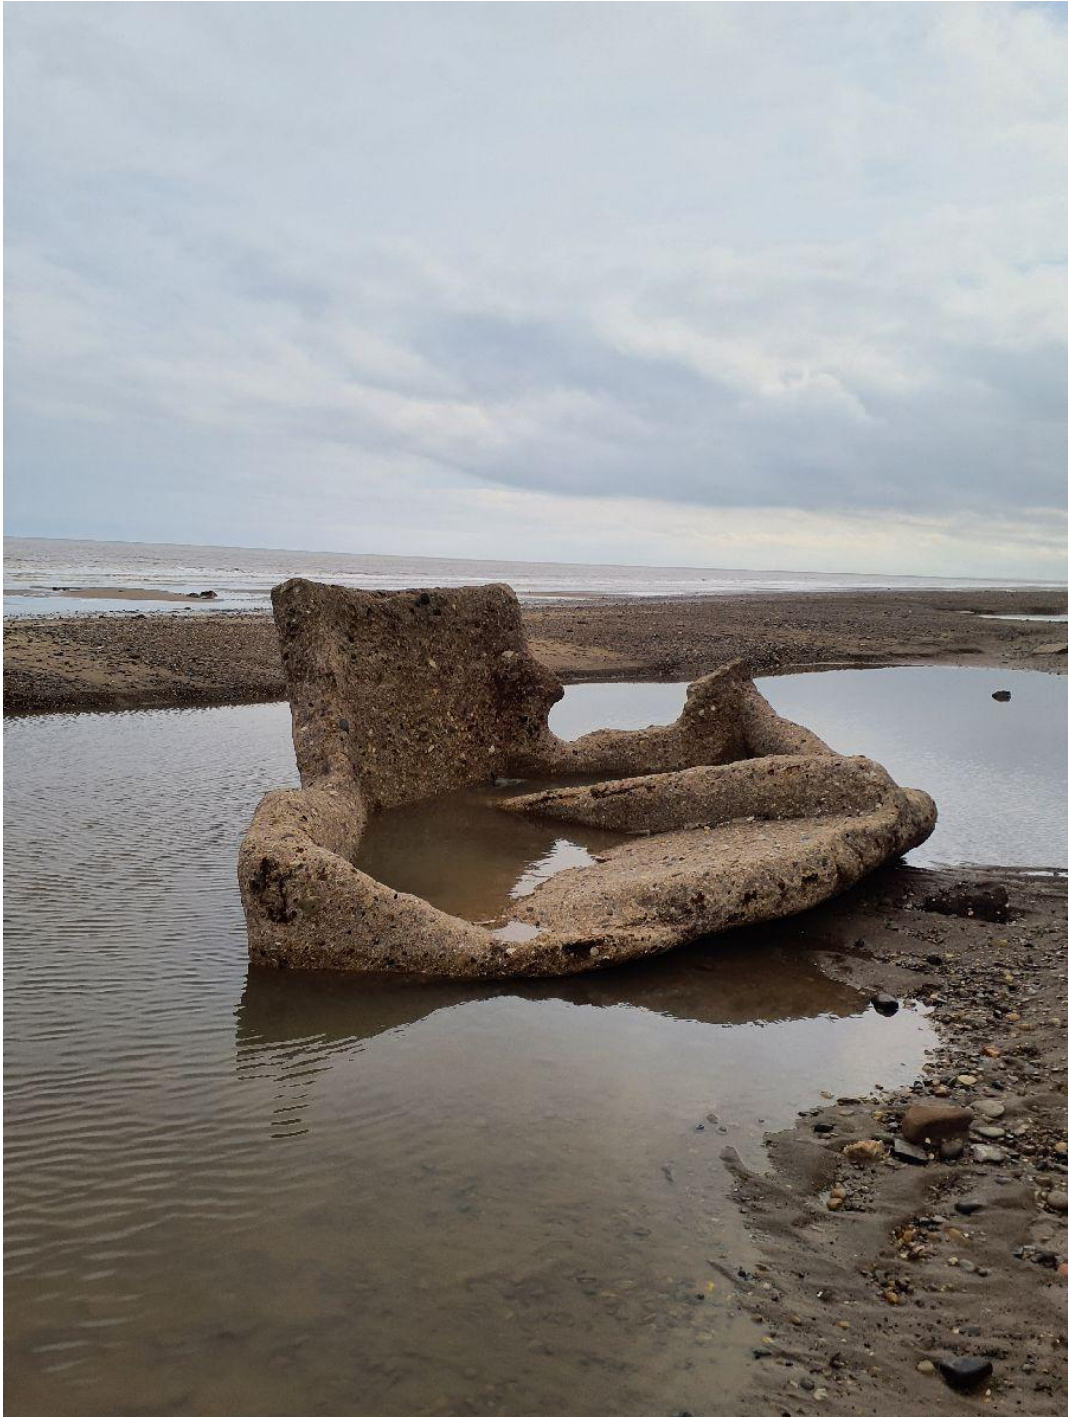
22. Record MHU21237 corresponds to a WWII-dated Pillbox. This record is presumed to correspond to the remains pictured in **Plate 24.4-6** present along the beach which lie in close proximity to the mapped record.

Plate 24.4-6 Remains of WWII Pillbox (MHU21237) Photographed Facing South-East.

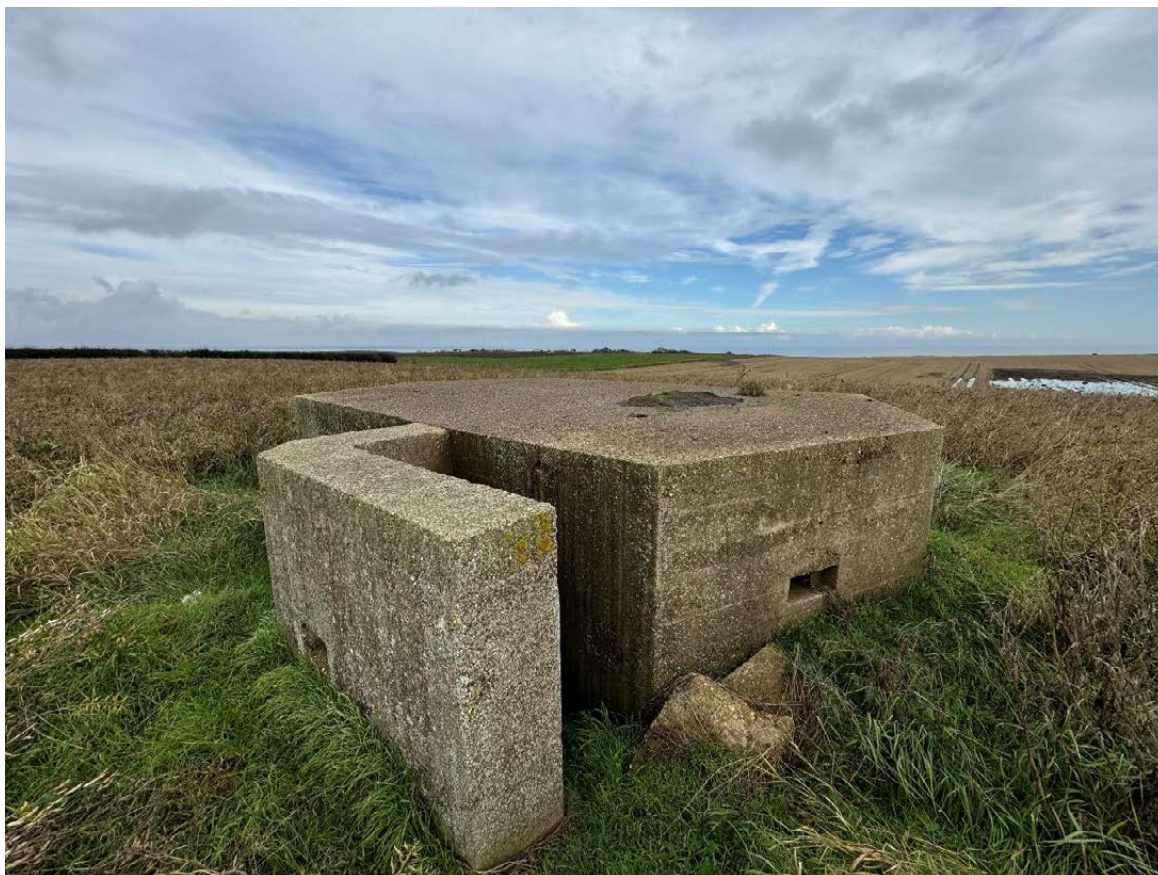
23. Record MHU18422 corresponding to a pillbox within the area known as 'The Hold' survives well as an example of a pillbox dating to WWII (**Plate 24.4-7**). The structure includes a surviving blast wall though the recorded barbed wire perimeter is not visible.

Plate 24.4-7 WWII Pillbox and Surviving Blast Wall (MHU18422) Photographed Facing South-East.

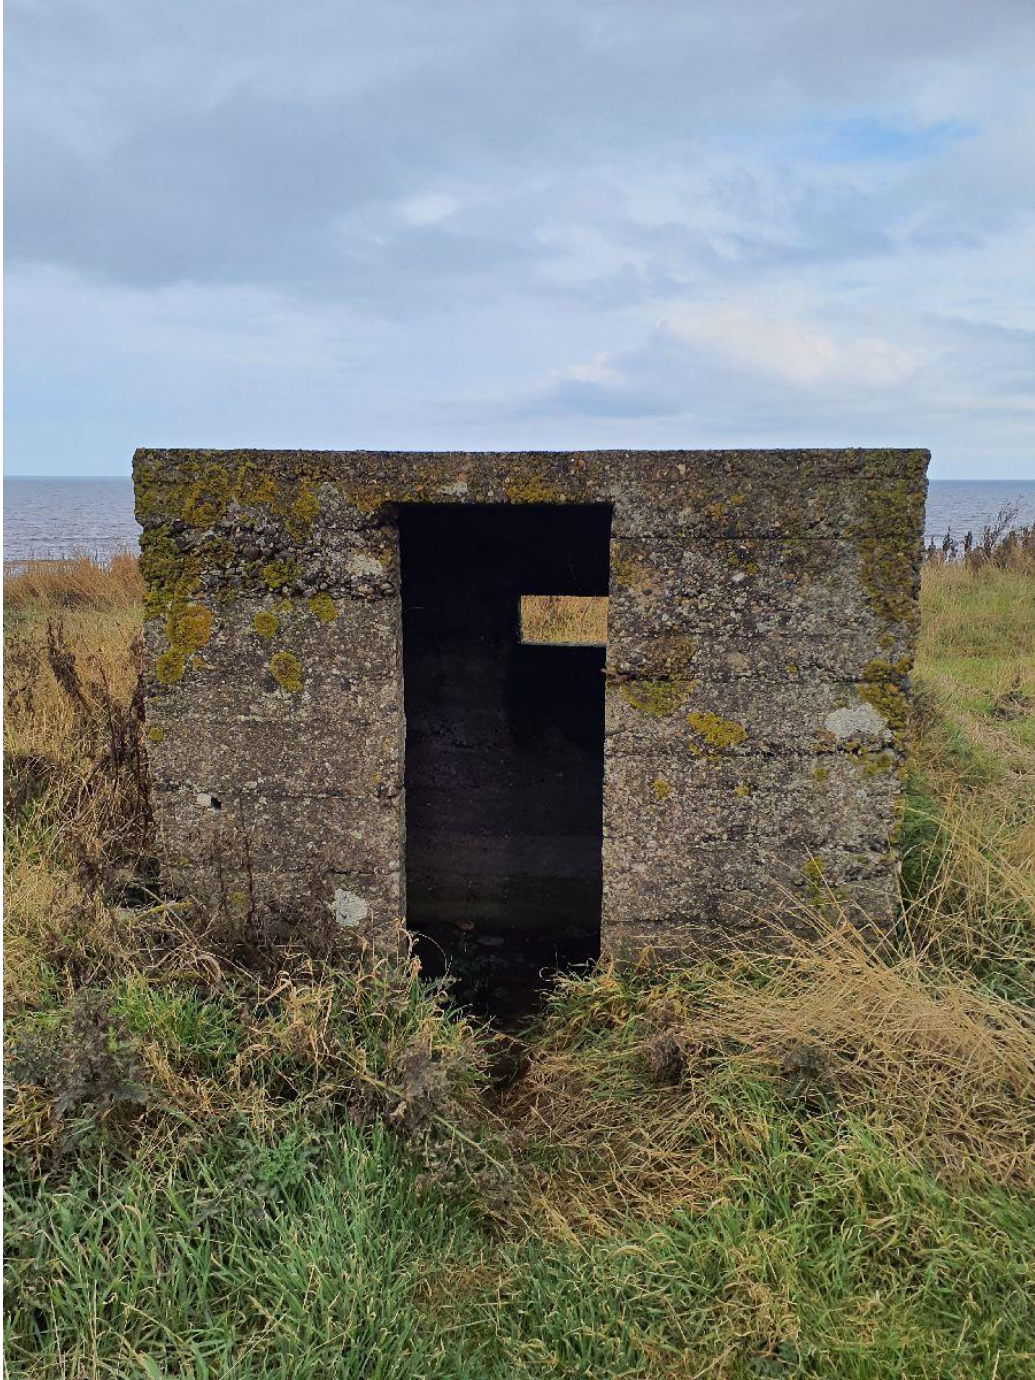
24. The Humber HER records a square pillbox (MHU21240) dating to the First World War (WWI) positioned along the line of a field boundary to the east of two earlier weapons pits.
25. The heritage walkover survey identified this pillbox which remains extant, at the cliff edge adjacent to an arable field. The structure survives well though weathered by its exposed position at the edge of the cliff (**Plate 24.4-8**).

Plate 24.4-8 WWI Square Pillbox (MHU21240), Photographed Facing Eastwards.

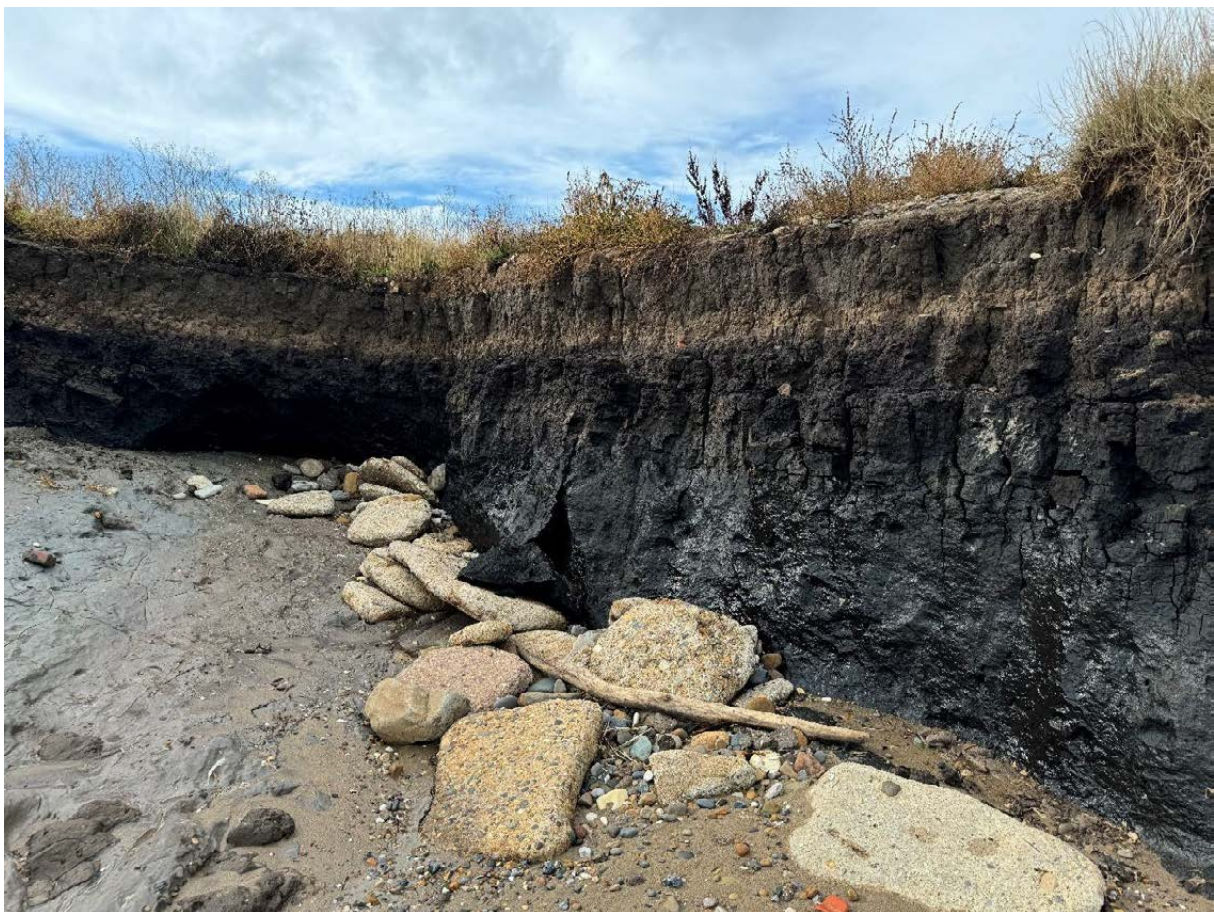
26. Withow Mere (MHU3862), corresponds to the Withow Gap Site of Special Scientific Interest (SSSI) and contains deposits of preserved remains of Mesolithic date. These deposits were observed within the cliff face at landfall (**Plate 24.4-9**).
27. Wooden rods and stakes are visible within the exposed Withow Mere deposits (**Plate 24.4-10**). These wooden rods and stakes are unlikely to correspond to those noted to have been recovered in the 1970s and 1980s (MHU9001), however, there is a likelihood that these surviving wood features are associated with the Lake Dwelling at Withow Gap (MHU9001). Existing evidence would suggest these deposits could date to either the Mesolithic or Neolithic periods.

Plate 24.4-9 Withow Mere (MHU3862), Photographed Facing Inland Towards the West.

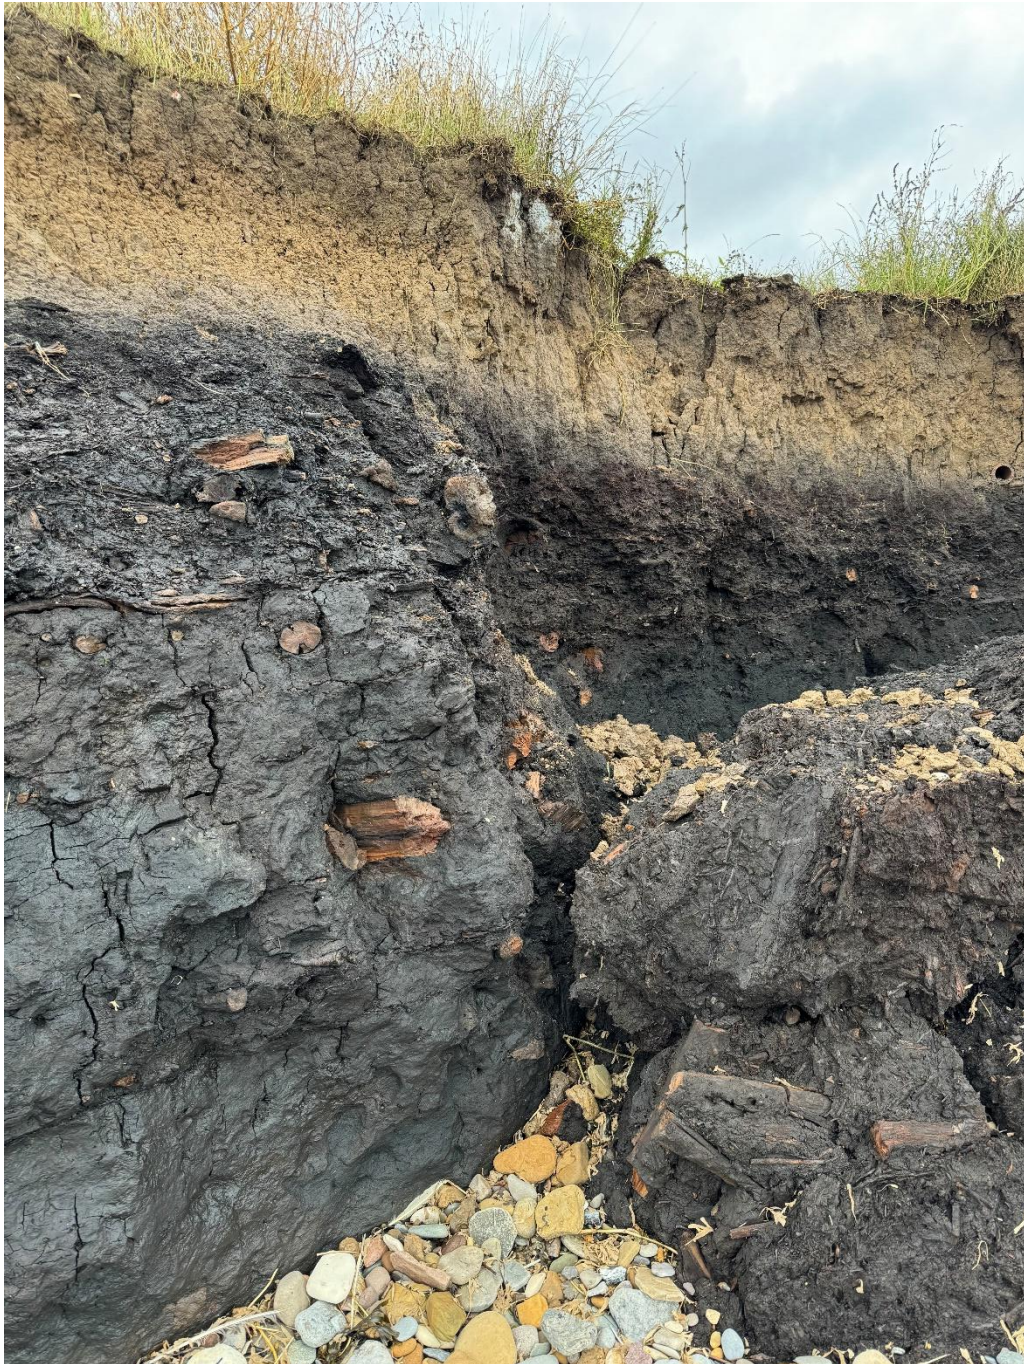
Plate 24.4-10 Exposed Wooden Features within Withow Mere, Photographed Facing North-West.

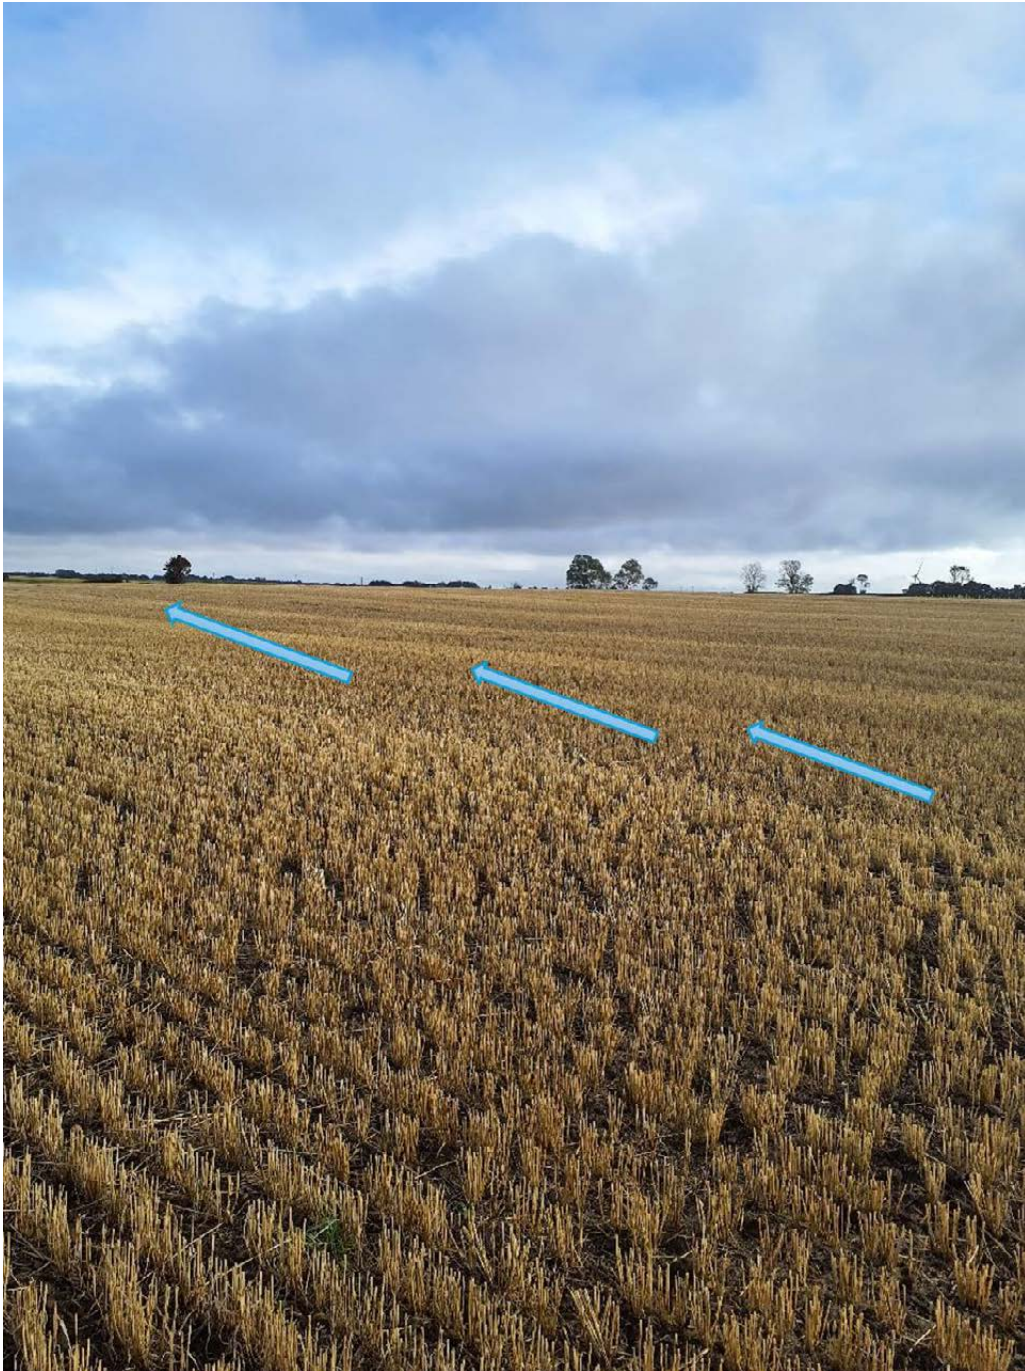
29. The site of a round barrow (MHU1689) dating to the Bronze Age is recorded within the Humber HER. This is shown as a tumulus on the 1854 OS map with aerial photography also showing a ring ditch.
30. During the walkover survey a slight rise in the arable field in which the asset is mapped was observed. This is shown in **Plate 24.4-11** however, though the location matches with the general asset location noted in the Humber HER, this slight undulation cannot be associated with the round barrow record with complete certainty.

Plate 24.4-11 Raised Ground Possibly Corresponding to Round Barrow (MHU1689), Photographed Facing North-East.

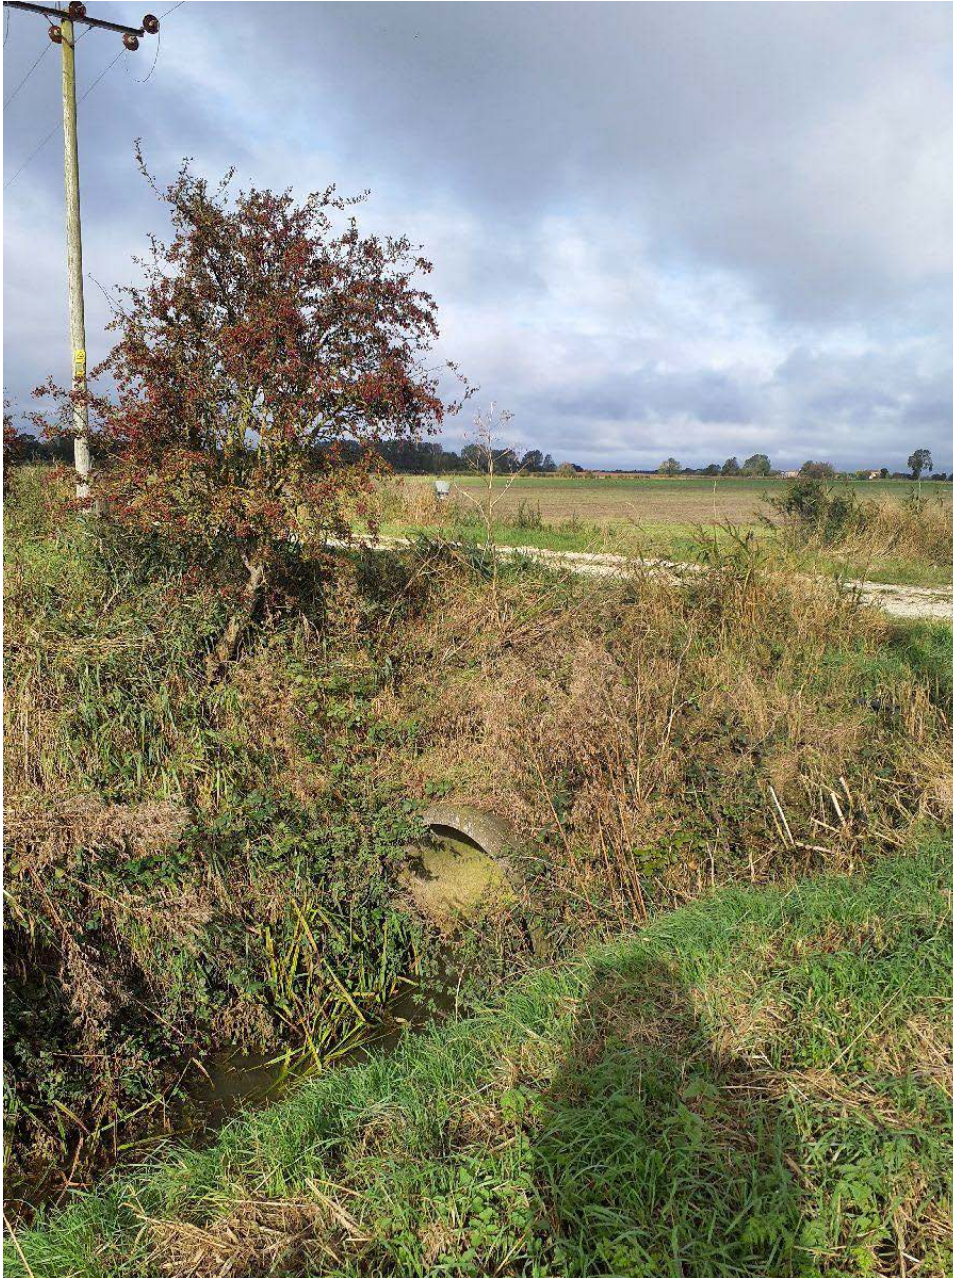
31. New Road Bridge (MHU13113) provides access across the Holderness Drain ditch which separates arable fields. The bridge was constructed sometime between the post-medieval period and the 19th century. The bridge is well-concealed by shrubbery and adjacent grasses **Plate 24.4-12**).
32. Due to the extent of foliage, observation of the condition of the structure was difficult.

Plate 24.4-12 New Road Bridge (MHU13113) Photographed Facing North.

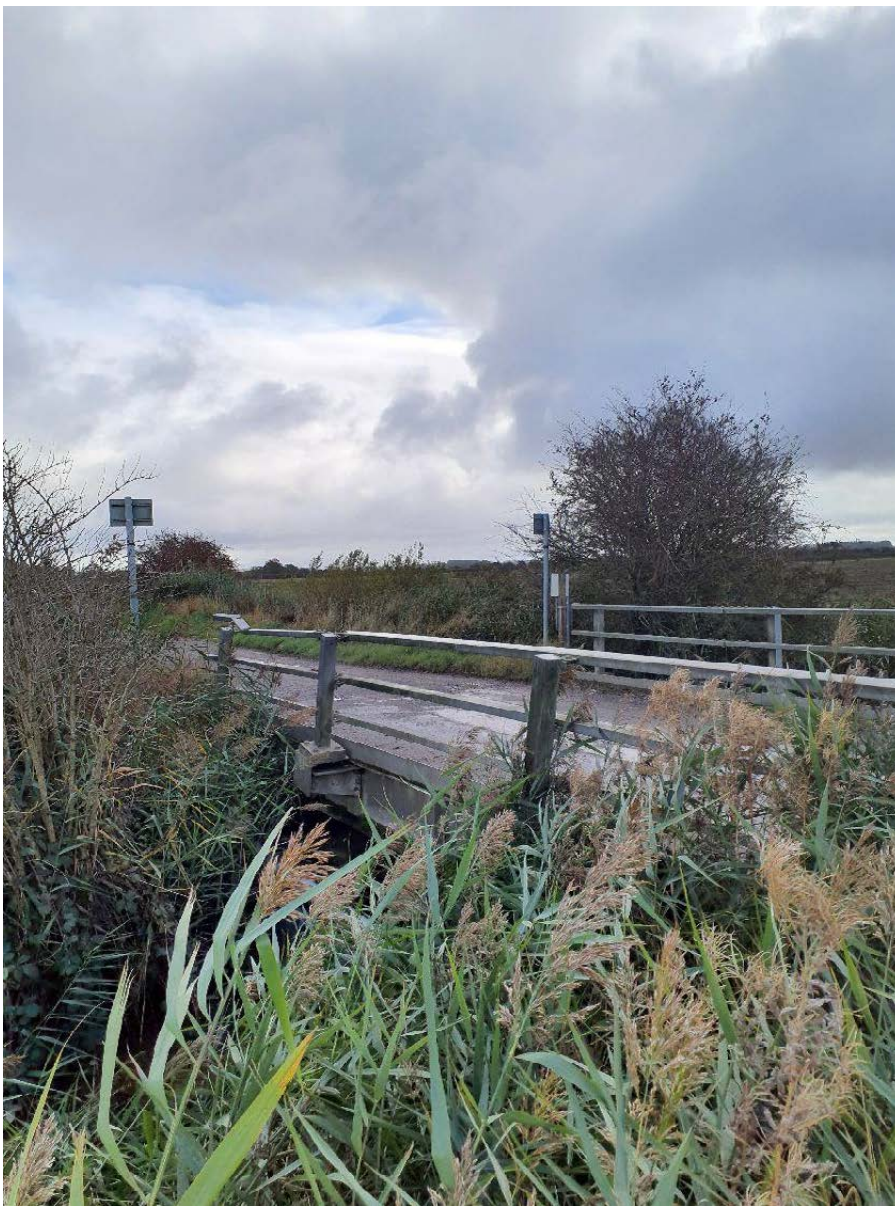
33. The Linleyhill Road Bridge (MHU13183) crosses the Holderness Drain along Carr Lane with the site of a bridge at this location mapped in the 19th century (on the 1891 OS map) as noted in the Humber HER.
34. The walkover survey observed the bridge at the mapped location (**Plate 24.4-13**). Given the extent of steel on the bridge, there is indication that the present-day bridge would have been built at the end of the 19th century, due to steel being used from the end of the period onwards, or that the bridge was reinforced in the modern period. Due to the surrounding foliage, the full extent of the bridge structure was concealed.

Plate 24.4-13 Linleyhill Road Bridge (MHU13183) Photographed Facing North.

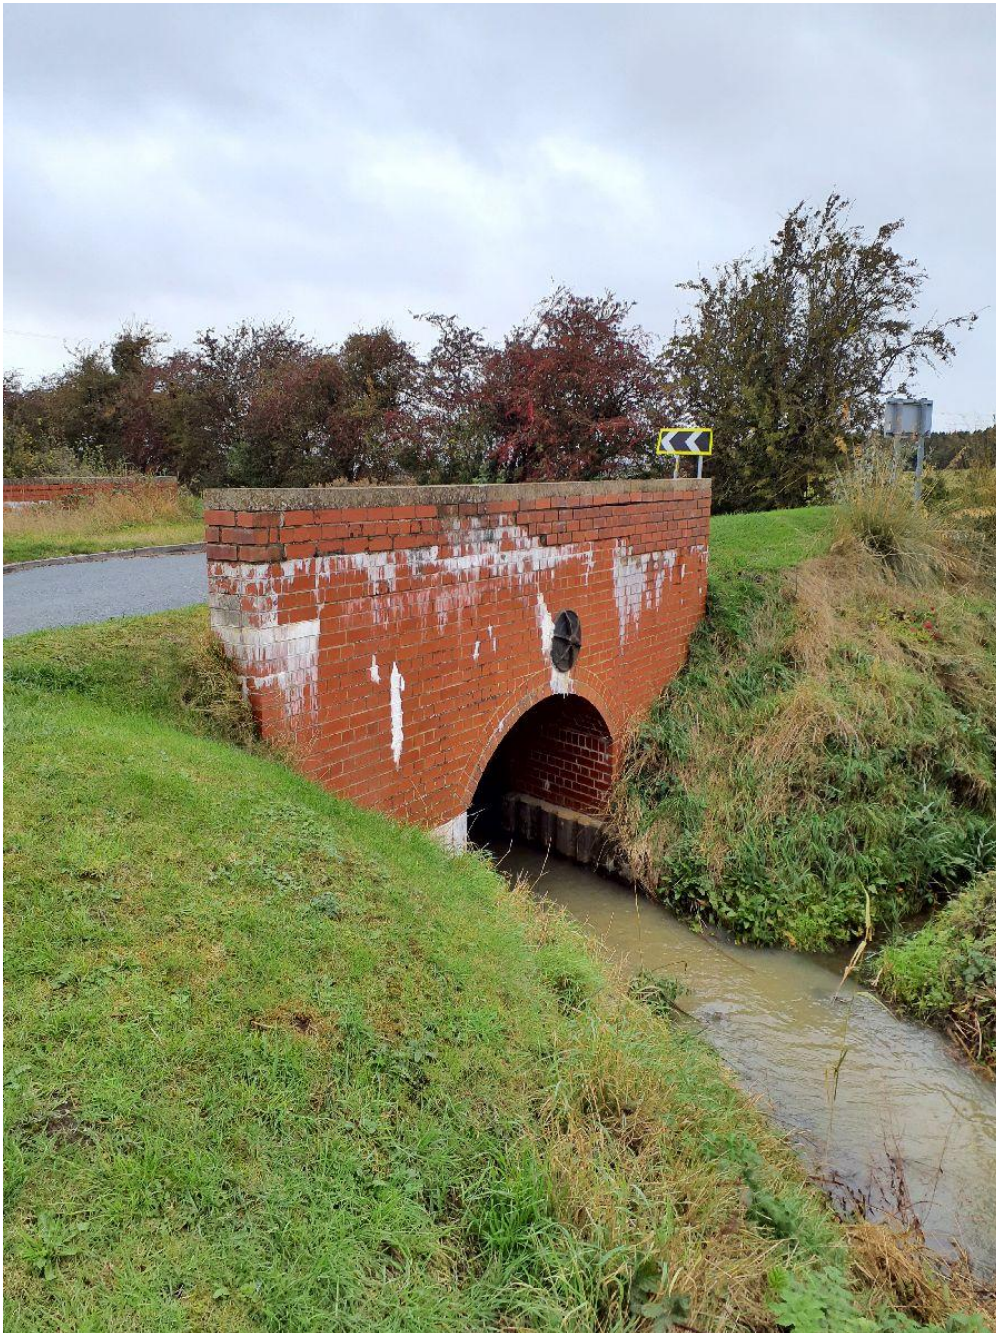
35. The Barf Hill Road Bridge (MHU13146) is positioned along an access route for the onshore ECC. The bridge is situated on Aike Lane and crosses the Coal Dike watercourse, north of Aike. The Humber HER notes this bridge to have been constructed sometime between the post-medieval period and the 19th century.
36. The bridge appears to be constructed predominantly from brick and survives well (**Plate 24.4-14**).

Plate 24.4-14 Barf Hill Road Bridge (MHU13146) Photographed Facing North-West.

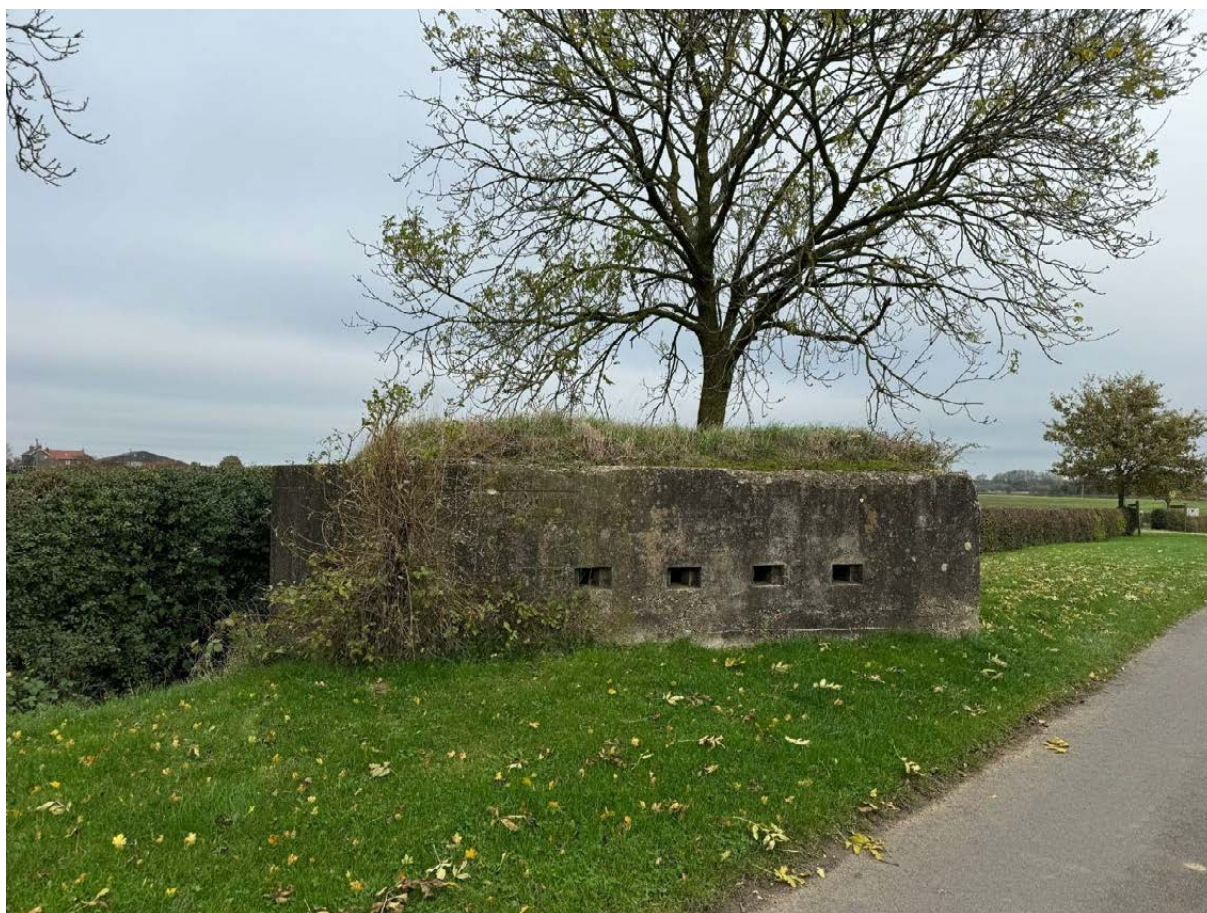
37. In addition to those assets recorded on the Humber HER, is a WWII pillbox recorded by the Defence of Britain Project on Scarborough Lane. It is noted that this record has two record numbers in the Defence of Britain database (S0005645 and S0002820) however both appear to correspond to the same pillbox.
38. The site walkover confirmed the extant remains of this pillbox which survive in relatively good condition with some damage from vegetation as shown in **Plate 24.4-15**.

Plate 24.4-15 Pillbox on Scarborough Lane as Recorded as Part of the Defence of Britain Project (S0005645/S0002820), Photographed Facing North-East.

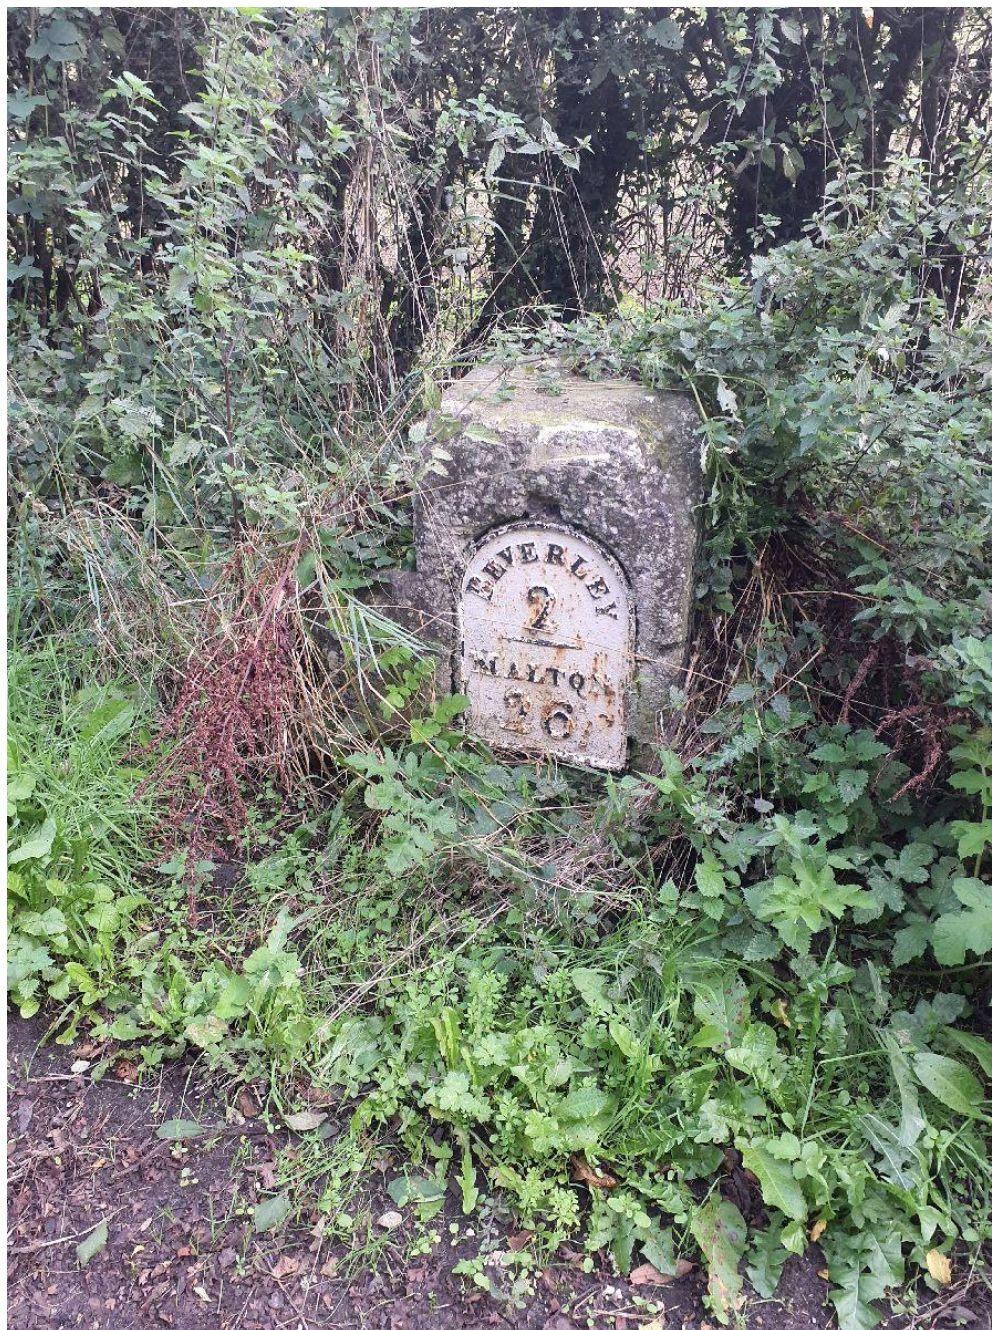
39. This milestone (MHU13033) was situated to the east of Cherry Burton along the footpath running adjacent to the north of the B1248. It survives in relatively good condition despite being partially covered by surrounding foliage (**Plate 24.4-16**).

Plate 24.4-16 Milestone Adjacent to B1248 (MHU13033), Photographed Facing North-East.
