DOGGER BANK D WIND FARM

Appendix 24.4 Onshore Heritage Walkover Report

Document Reference No: 2.24.4

Date: June 2025

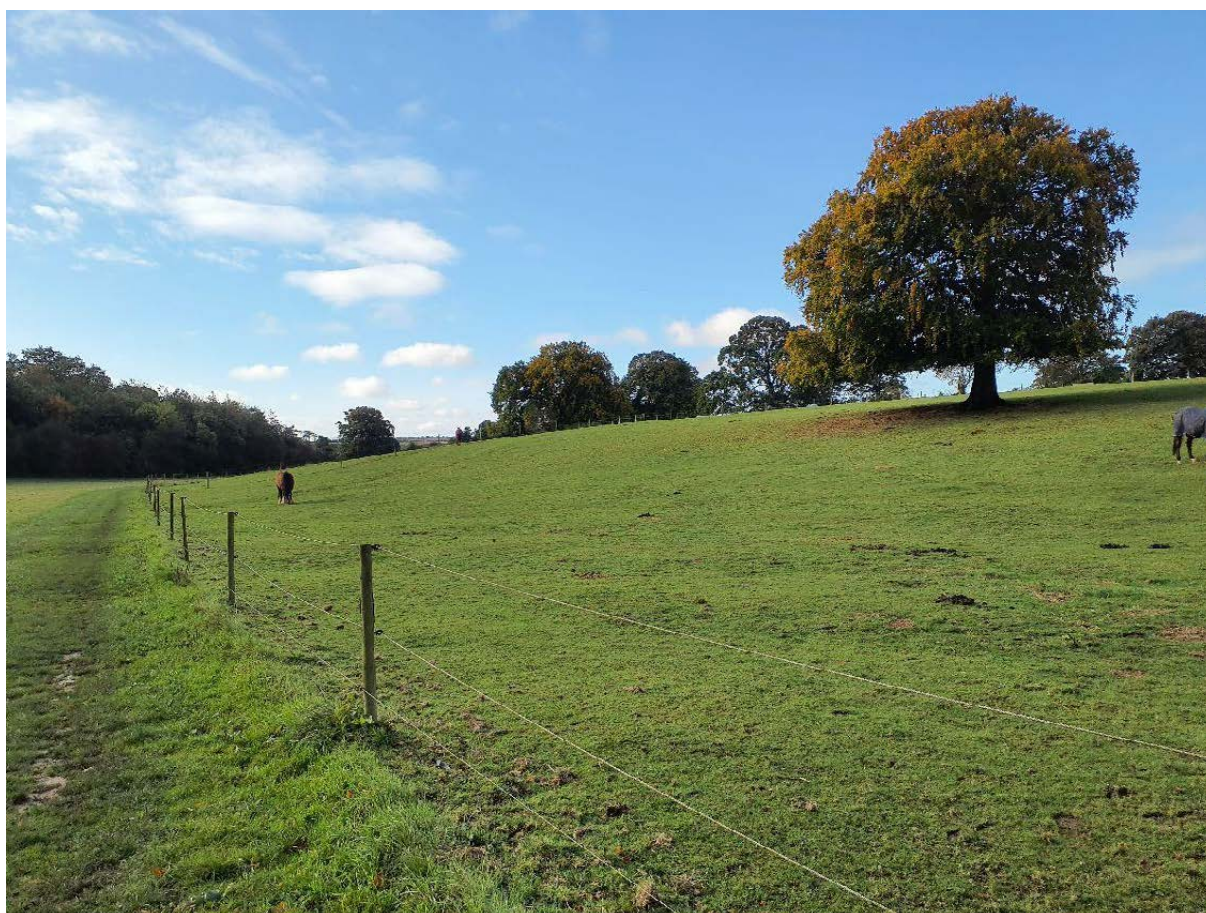
40. South of Walkington is Walkington Park (MHU12968). Though undated in the Humber HER, the parkland was mapped on the 1893 OS Map.
41. The walkover survey was completed crossing the public right of way running through the present day Walkington Park. It was noted that the western half of the land is used for pasture. This is shown in **Plate 24.4-17**.

Plate 24.4-17 Walkington Park Photographed Facing South-West (MHU12968).

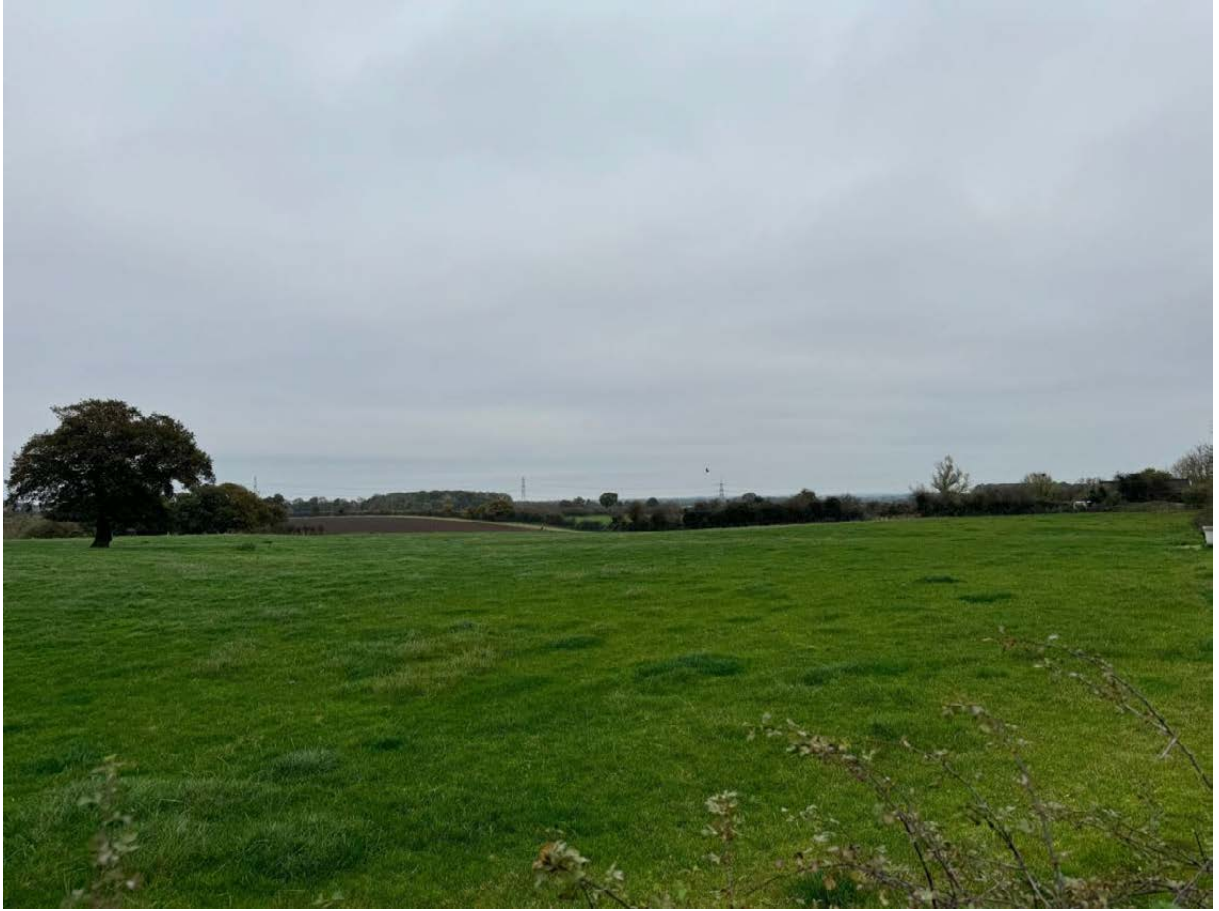
42. Record MHU9750 corresponds to a manor house that stood within the SMV at Bentley.
43. No access could be obtained to the site of the asset during the walkover survey; however, the mapped location of the manor house could be seen from Bentley Road to the south. From this position, possible earthworks could be observed as shown in **Plate 24.4-18**. Though the earthworks were faintly visible, these can be confirmed by the LiDAR imagery of the area correlating to the earthworks.

Plate 24.4-18 Faint Earthworks Corresponding to the Site of Manor House, Bentley (MHU9750) Photographed Facing North Taken from South Along Bentley Road.
