DOGGER BANK D WIND FARM

Preliminary Environmental Information Report

Appendix 21.2 Fluvial Geomorphology Baseline Survey

Document Reference No: 2.21.2

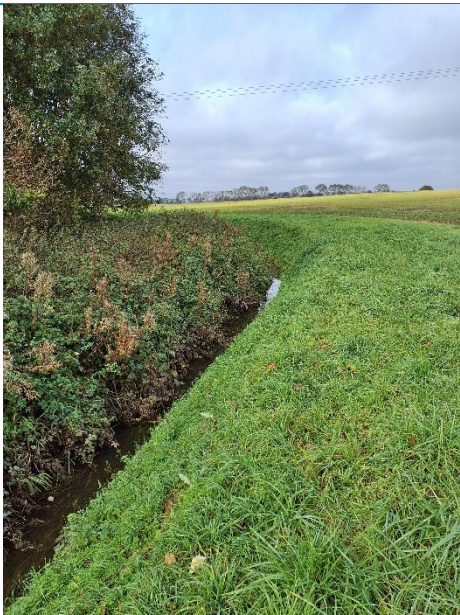
Parameter	Description
Grid Reference	TA 14989 52718
Overview	<p>Dunnington Sewer is an artificial, straight and deep channel of uniform width. Access to the channel was good. Woodland and arable land characterise the left and right banks, respectively. Right bank vegetation is maintained by mowing.</p>

Flow Conditions	There is no diversity in flow type; stagnant water was observed in the channel.
Channel Form, Soils and Substrates	The watercourse has a straight, uniform width channel. The banks are steep and vegetated. There were no signs of dredging, but the right bank grass cover is regularly mowed. Bank toes are vegetated, and no signs of erosion or deposition were observed. Bank and substrate materials were obscured by vegetation and turbid water respectively. The watercourse has a bankfull width and depth of 2.5 m and 2 m respectively, and a wetted width of 1.5 m. The wetted depth was obscured by turbid water.
Floodplain Connectivity	There is no connectivity with the floodplain.
In Channel / Riparian Vegetation	In-channel vegetation was observed, while grass and herbaceous vegetation covered the right and left banks respectively. There is no diversity in riparian vegetation on the right floodplain (due to arable land use), but a mixture of herbaceous flora and trees was observed on the left bank.

Modifications / Structures/ Pollution	The watercourse is an artificial straight channel with uniform width. There were no in-channel structures in the surveyed section.

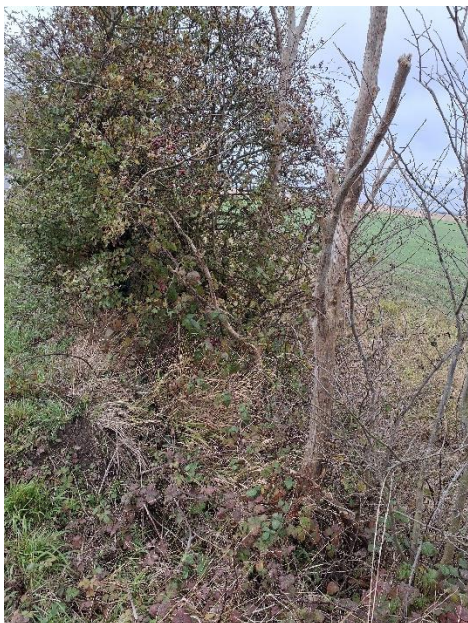
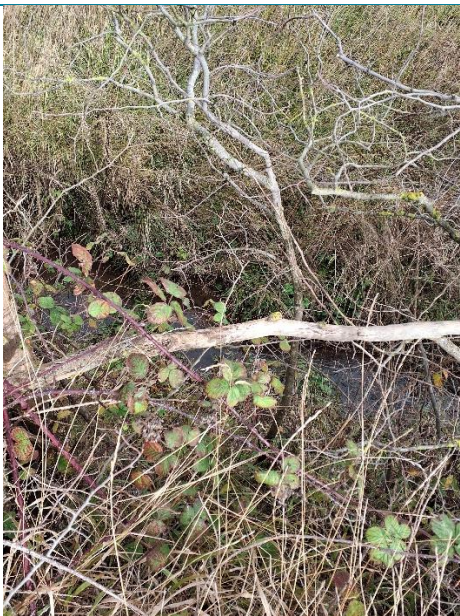
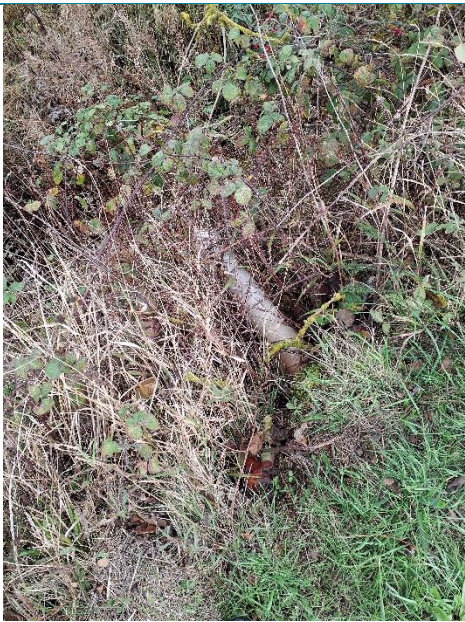
Table 21.2-4 Geomorphological Walkover Survey of Towns Drain

Parameter	Description
Grid Reference	TA 12065 51476
Overview	<p>Towns drain is an artificial straight and deep channel of uniform width. Access to the channel was poor due to a thick hedge; observations were made from one access point. Adjacent land use on both banks was arable, although the Orange Road is on the left bank of the drain. There were no signs of vegetation clearance or dredging.</p>

Flow Conditions	Observations were obscured due to vegetation cover.
Channel Form, Soils and Substrates	The watercourse has a straight and uniform width channel. Banks were vegetated by a mixture of grass and herbaceous vegetation. At the point of access, bank toe protection was not observed. Bank materials were obscured while gravel substrate was observed in places. Signs of erosion and deposition were obscured, and channel dimensions could not be accurately estimated.
Floodplain Connectivity	There is no connectivity with the floodplain.
In Channel / Riparian Vegetation	The right bank floodplain was covered by grass and herbaceous flora, while a hedge covered the left bank floodplain.
Modifications / Structures / Pollution	Two pipe inlets were observed on the left bank, and the Orange Road is on the left bank of the water course.

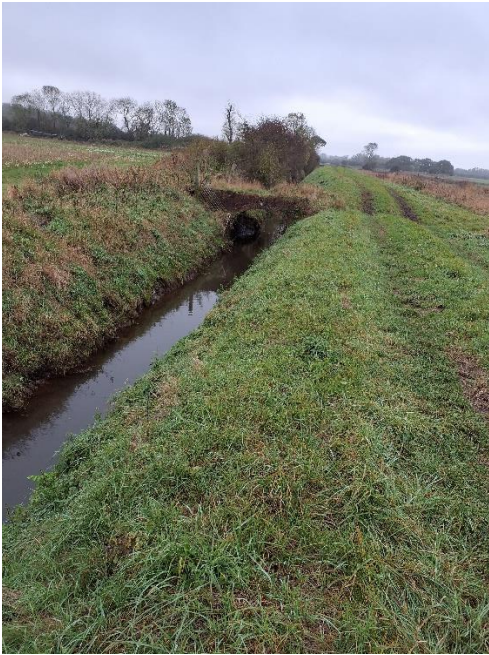
Parameter	Description
Grid Reference	TA 10487 49661
Overview	Mickley Dike is a straight channel with a uniform width. Land use on the left bank floodplain is tourism (caravan park), and arable land on the right bank floodplain. Access to the channel was good and there were signs of recent vegetation clearance and dredging.
Flow Conditions	No perceptible flow was observed.
Channel Form, Soils and Substrates	The watercourse has a straight and uniform width channel. Recent dredging activities have removed potential signs of erosion or deposition from the channel. Both bank and substrate materials were silt. While bank toe was vegetated in some sections, in others vegetation had recently been removed by dredging. The watercourse has a bankfull width and depth of 4 m respectively, and a wetted width and depth of 1 m and 0.3 m.
Floodplain Connectivity	There is no connectivity with the floodplain.

Parameter	Description
Grid Reference	TA 10487 49661
In Channel / Riparian Vegetation	There was limited in-channel vegetation and both banks were grassed. There is no diversity in riparian vegetation as adjacent lands are arable.
Modifications / Structures/ Pollution	<p>Embankments were observed on both sides of the channel. A trash screen, culvert and bridge crossings were also observed.</p>

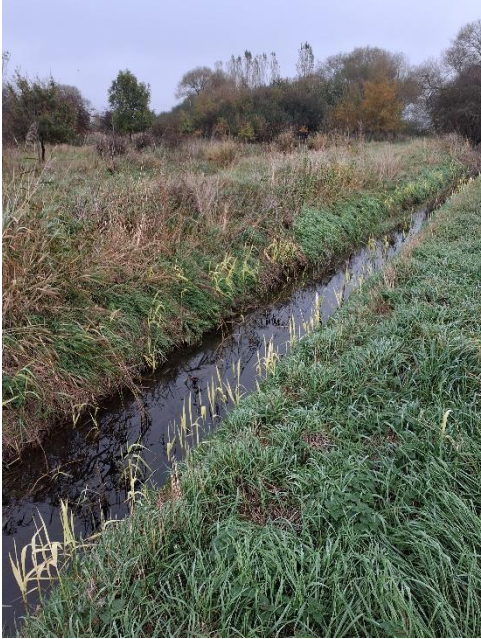
Parameter	Description
Grid Reference	TA 09973 49797
Overview	Holts Drain is an artificial straight channel of uniform width. Access to the channel was good. The adjacent land use is rough pasture. There were no signs of recent dredging and vegetation clearance.

Flow Conditions	There is no diversity in flow type, stagnant water was observed in the channel.
Channel Form, Soils and Substrates	The watercourse has a straight and uniform width channel. Both banks were vegetated, and thus, bank materials were obscured. Also, due to in-channel vegetation, substrate materials were not observed. There were no visible signs of erosion or deposition. The watercourse has a bankfull width and depth of 3 m and 1.5 m respectively, and a wetted width of 1.5 m and wetted depth of 0.4 m.
Floodplain Connectivity	There is limited connectivity with the floodplain due to the incised nature of the channel.

In Channel / Riparian Vegetation	The left bank floodplain was characterised by grass, herbaceous flora and a deciduous tree; grasses covered the right bank floodplain.
Modifications / Structures / Pollution	The channel is straight and has a uniform width, but there were no in-channel modifications / structures observed.

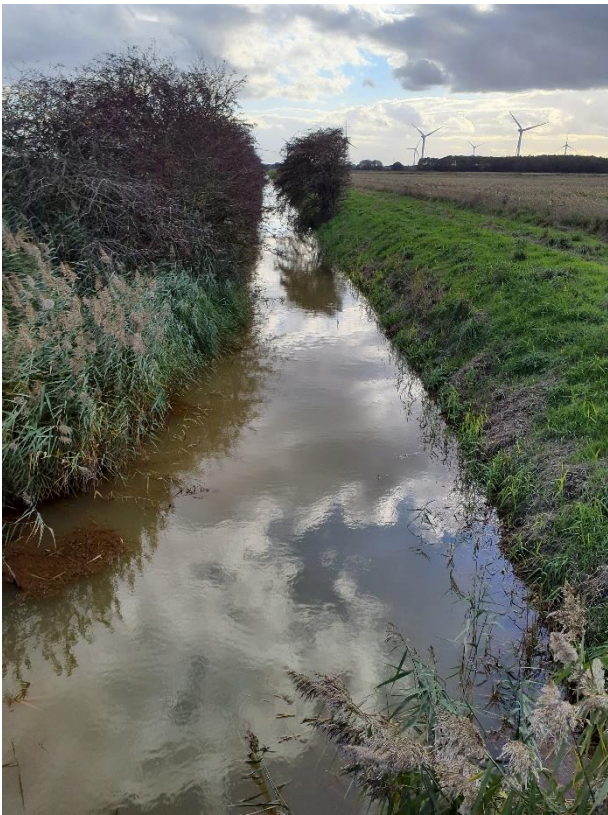
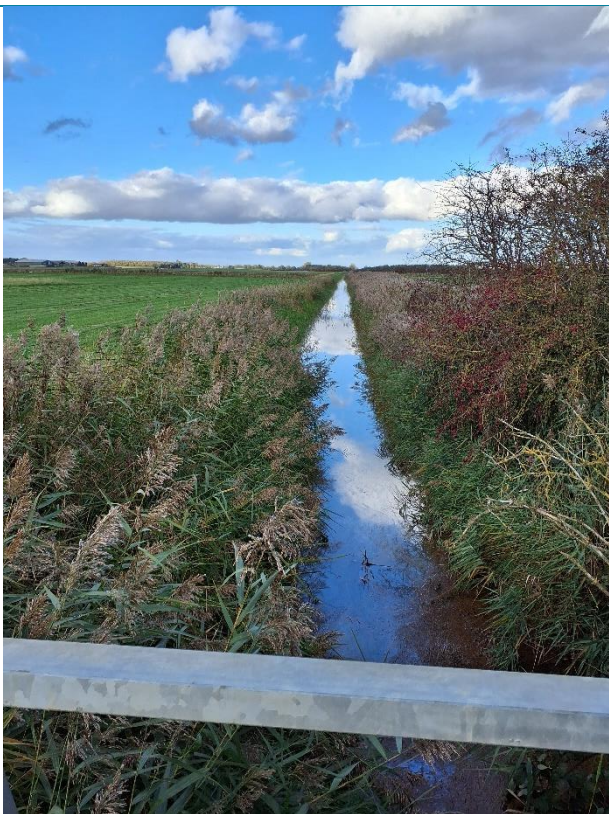
Table 21.2-9 Geomorphological Walkover Survey of Holderness Drain (Main River)

Parameter	Description
Grid Reference	TA 08098 45670
Overview	<p>Holderness Drain is an artificial drainage channel of uniform width surrounded by arable land on both banks. There was good channel access during site visit.</p>

Flow Conditions	Holderness Drain displayed little variation in flow type as stagnant water was observed in-channel.
Channel Form, Soils and Substrates	The drain is a deep, artificial drainage channel of uniform width. The substrate material was obscured due to turbid water. The bank material was silt, and the watercourse has a bankfull width and depth of 5 m and 1.5 m, respectively. The wetted width was obscured by vegetation growth while turbid water obscured the wetted depth.
Floodplain Connectivity	There is no connectivity with the floodplain.
In Channel / Riparian Vegetation	There was no in-channel vegetation observed. Both banks were vegetated with grasses and herbaceous vegetation. Land use on both floodplains was arable with no diversity in riparian vegetation.
Modifications / Structures / Pollution	The channel is artificial and there were no in-channel modifications / structures observed.

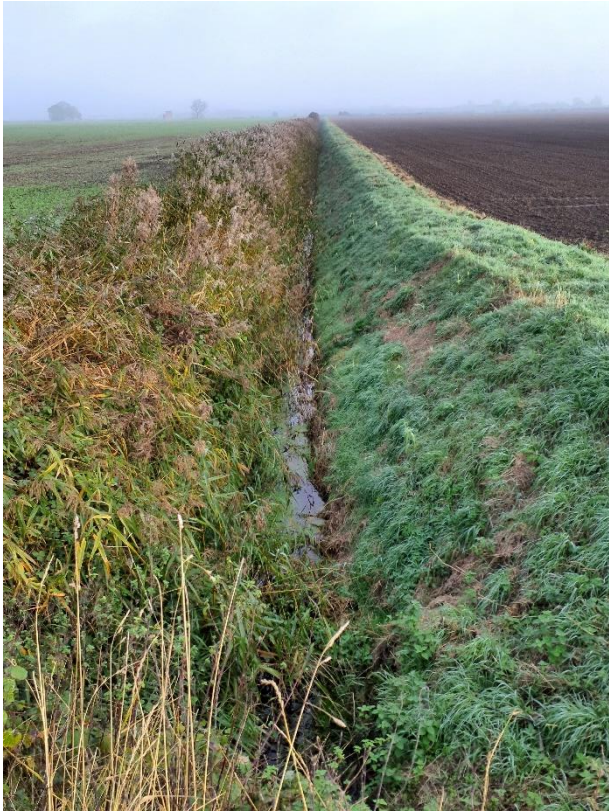
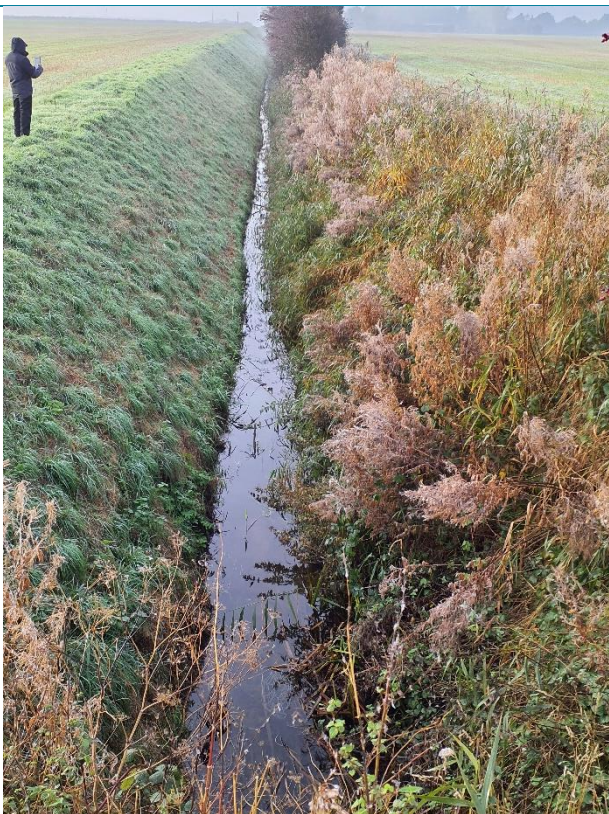
Parameter	Description
Grid Reference	TA 08555 48276
Overview	<p>Burshill Park Drain is an artificial, straight channel of uniform width. Adjacent land use was arable on both banks. In channel vegetation was present; herbaceous plants covered the left bank and grass was present on the right bank.</p>

Flow Conditions	There is no diversity in flow type, stagnant water was observed in the channel.
Channel Form, Soils and Substrates	The watercourse has a straight and uniform width channel. Both banks were vegetated with grasses on the right banks and herbaceous plants on the left bank. Due to in-channel vegetation, substrate materials were not observed. There were no visible signs of erosion or deposition. The watercourse has a bankfull width and depth of 5 m respectively and a wetted width and depth of 1 m and 0.3 m respectively.
Floodplain Connectivity	There is no connectivity with the floodplain.
In Channel / Riparian Vegetation	Channel banks were vegetated with grass and brush with brush growth in the channel. There is no diversity in riparian vegetation on the floodplains due to arable land use.
Modifications / Structures / Pollution	The channel is straight and has a uniform width, but there were no in-channel modifications / structures observed.

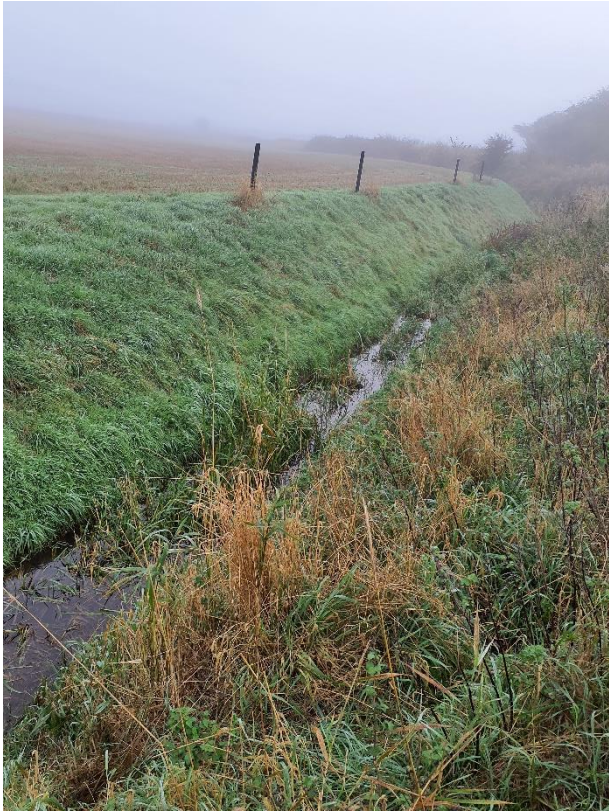
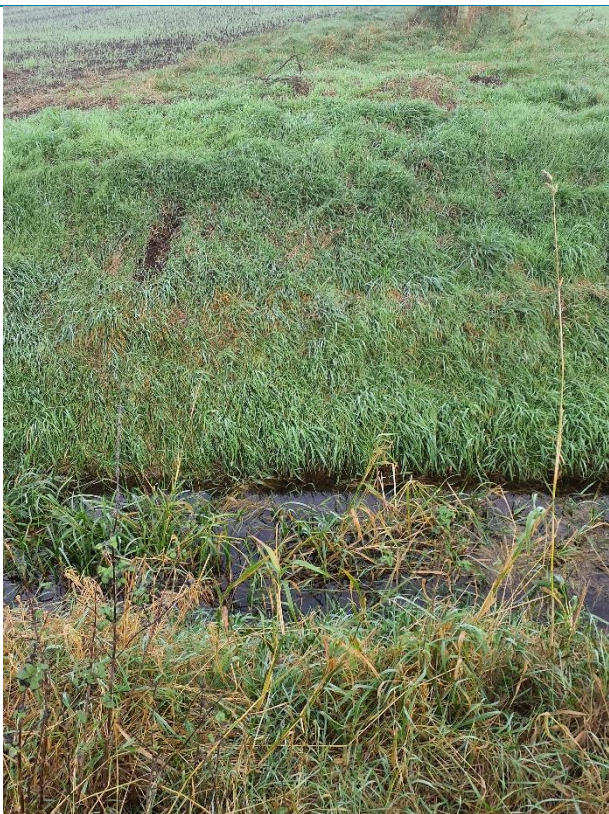
Parameter	Description
Grid Reference	TA 08550 47148
Overview	<p>Heighholme Drain is an artificial, straight channel of uniform width. Adjacent land was arable on both banks. Significant in-channel vegetation was present and both banks were grassed.</p>

Flow Conditions	There is no diversity in flow type, stagnant water was observed in the channel.
Channel Form, Soils and Substrates	The watercourse has a straight, uniform width channel. Both banks were vegetated and there were no signs of recent vegetation clearance or dredging. Due to in-channel vegetation, substrate materials were not observed. There were no visible signs of erosion or deposition. The watercourse has a bankfull width and depth of 4 m and 2.5 m respectively, and a wetted width of 1 m. The wetted depth was obscured by in-channel vegetation.
Floodplain Connectivity	There is no connectivity with the floodplain.
In Channel / Riparian Vegetation	There was significant in-channel vegetation (rushes) and grass was present on both banks. There is no diversity in riparian vegetation on the floodplains due to arable land use.
Modifications / Structures/ Pollution	The channel is straight and has a uniform width, but there were no in-channel modifications / structures observed.

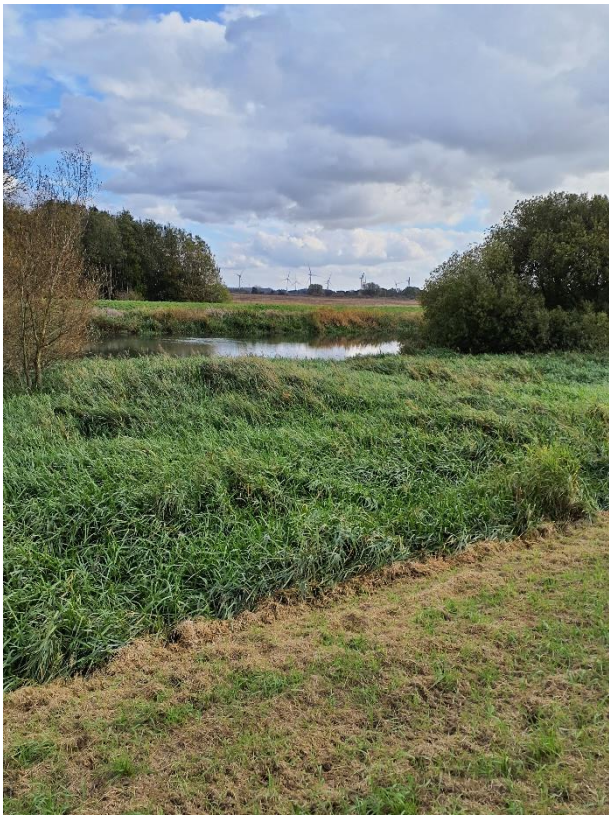
Parameter	Description
Grid Reference	TA 05493 45475
Overview	<p>The River Hull is bounded by embankments on both sides with arable land use on the right-hand bank and woodland on the left-hand bank. Access to the river was poor due to vegetation and boggy floodplain soils.</p>

Flow Conditions	The River Hull displays little variation in flow conditions, which are characterised by glide flows.
Channel Form, Soils and Substrates	The river channel is embanked on both sides. Substrates could not be observed due to dense vegetation. The watercourse has a bankfull width of 25 m and a wetted width of 10 m. The bankfull depth and wetted depth were obscured due to inaccessible banks.
Floodplain Connectivity	There is connectivity with the immediate floodplain, although embankments on both banks constrain the potential for wider connectivity.
In Channel / Riparian Vegetation	No in-channel vegetation is present in the River Hull. Both banks are vegetated with grasses and trees, however canopy cover is low (<30%).
Modifications / Structures / Pollution	There is an embankment on both banks of the River Hull, but no other modifications / structures are present.

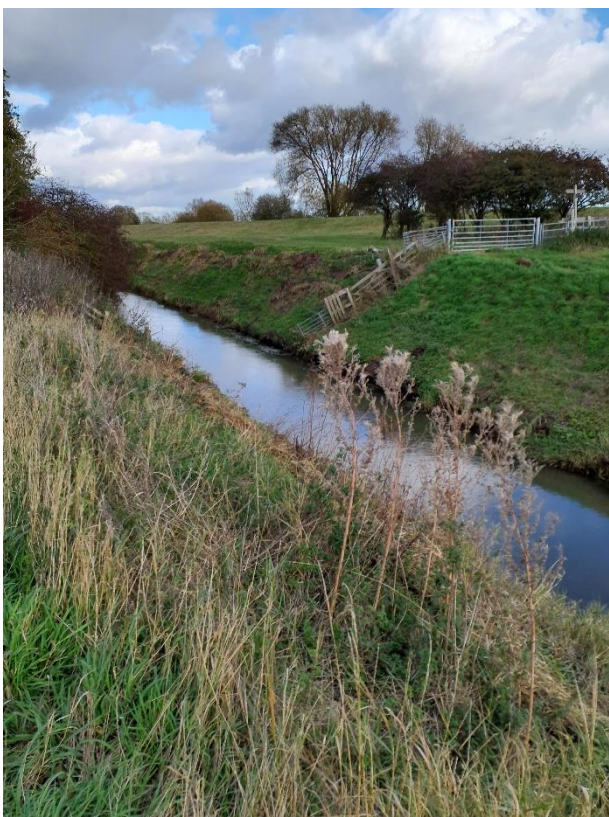
Parameter	Description
Grid Reference	TA 05428 45589
Overview	<p>The Beverley and Barmston Drain is an artificial drainage channel of uniform width with arable land use on both banks. There was good access to the channel and signs of recent dredging were observed.</p>

Flow Conditions	There is no variation in flow type. Stagnant water was observed in the channel.
Channel Form, Soils and Substrates	The watercourse is an artificial drainage channel of uniform width. There were no signs of erosion or deposition observed, but the channel had been recently desilted/dredged. The substrate material was obscured by turbid water. The watercourse has a bankfull width and depth of 10 m and 5 m respectively, and a wetted width of 3 m. The wetted depth was obscured by turbid water.
Floodplain Connectivity	There is no connectivity with the floodplain.

Parameter	Description
Grid Reference	TA 05428 45589
In Channel / Riparian Vegetation	There was no in-channel vegetation observed and both banks of the Beverley and Barmston Drain were vegetated with grasses. There is no diversity in riparian vegetation on the floodplains due to arable land use.
Modifications / Structures / Pollution	The channel is artificial and there were no in-channel structures observed. The channel had recently been desilted.

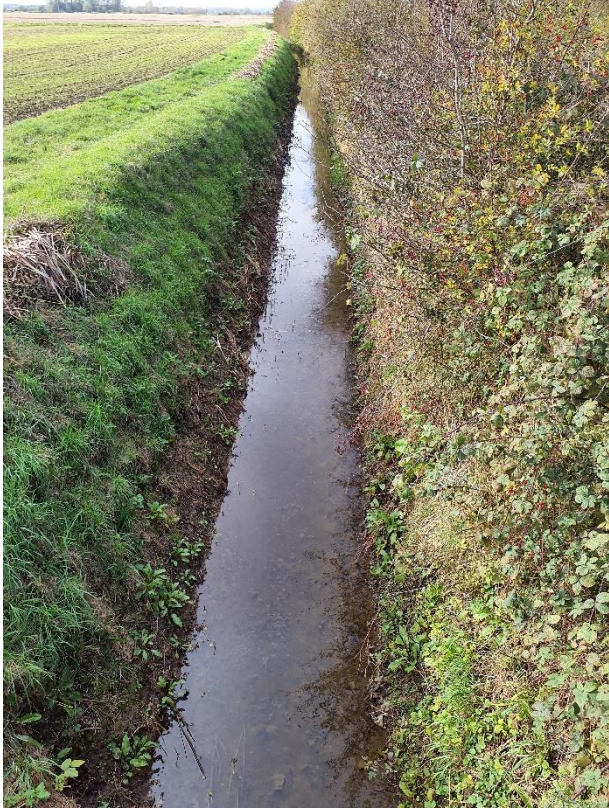
Parameter	Description
Grid Reference	TA 04497 46994
Overview	<p>Coal Dike is a straight, deep incised channel of uniform width. The adjacent land use is arable and access to the channel was good. No signs of recent dredging were observed, but weed removal had been carried out prior to site visit.</p>

Parameter	Description
Grid Reference	TA 04497 46994
Flow Conditions	Coal Dike displayed riffles in some places but a well-defined pool-riffle sequence was not observed. In most areas there was no perceptible signs of flow.
Channel Form, Soils and Substrates	The watercourse is a straight, deep incised channel of uniform width. There were no signs of erosion or deposition observed. Gravel bed was observed in one location (immediately downstream of the bridge) but there appeared to be no transfer of gravel from upstream. A silt bed was observed along the rest of the reach. The observed bank material was silt. The watercourse has a bankfull width and depth of 3 m and a wetted width and depth of 0.8 m and 0.1 m, respectively.
Floodplain Connectivity	There is no connectivity with the floodplain.
In Channel / Riparian Vegetation	No in-channel vegetation was observed. Grasses and herbaceous vegetation were observed on the right and left banks respectively. Signs of recent weed removal from the channel were observed.

Modifications / Structures / Pollution	There were no in-channel modifications / structures observed. A bridge crossing was noted along the survey reach.

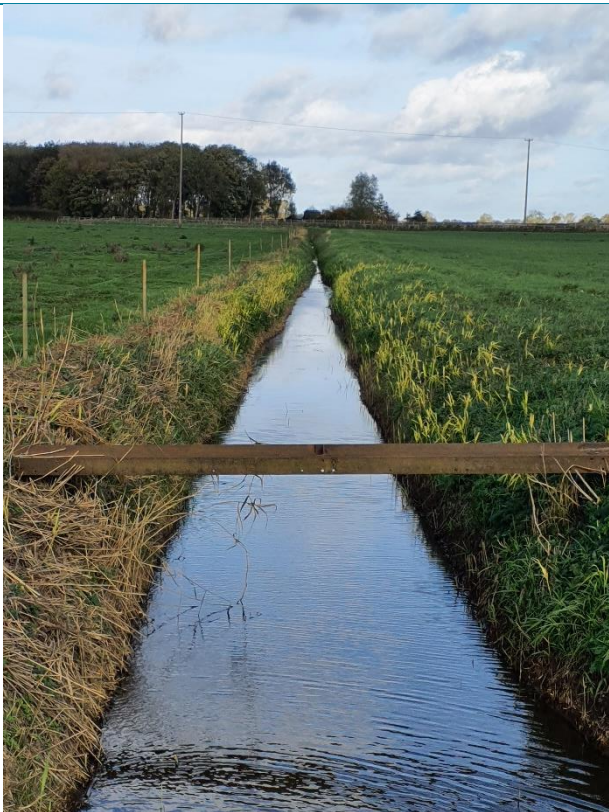
Parameter	Description
Grid Reference	TA 04525 45603
Overview	Watson Drain is an artificial drainage channel of uniform width. There is good access to the channel and adjacent land use is arable. Signs of recent dredging and vegetation clearance were not observed.

Flow Conditions	Glide flows characterise the reach.
Channel Form, Soils and Substrates	The watercourse is a straight, artificial channel of uniform width. There were no signs of erosion or deposition observed. The substrate was obscured by turbid water and bank materials were also obscured by vegetation. The watercourse has bankfull and wetted widths of 3 m and 1 m, respectively. Bankfull and wetted depths were obscured.
Floodplain Connectivity	There is no connectivity with the floodplain.
In Channel / Riparian Vegetation	No in-channel vegetation was observed. Both bank face and bank top were vegetated with grasses. There is no diversity in riparian vegetation on the floodplains due to arable land use.
Modifications / Structures / Pollution	The channel is artificial and there were no in-channel modifications / structures observed.

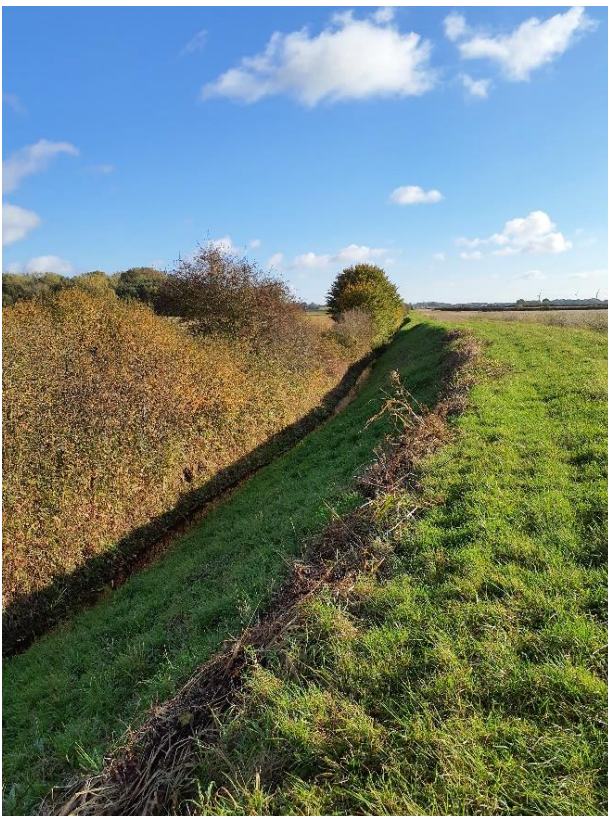
Parameter	Description
Grid Reference	TA 03214 45620
Overview	<p>A second reach along Boundary Drain was observed approximately 1.2 km upstream of the location recorded in Table 21.2-16. Here, Boundary Drain is a deep, artificial drainage channel of uniform width. The geomorphic features observed at this second crossing were the same as those described for Boundary Drain in Table 21.2-16 and are not described further.</p>

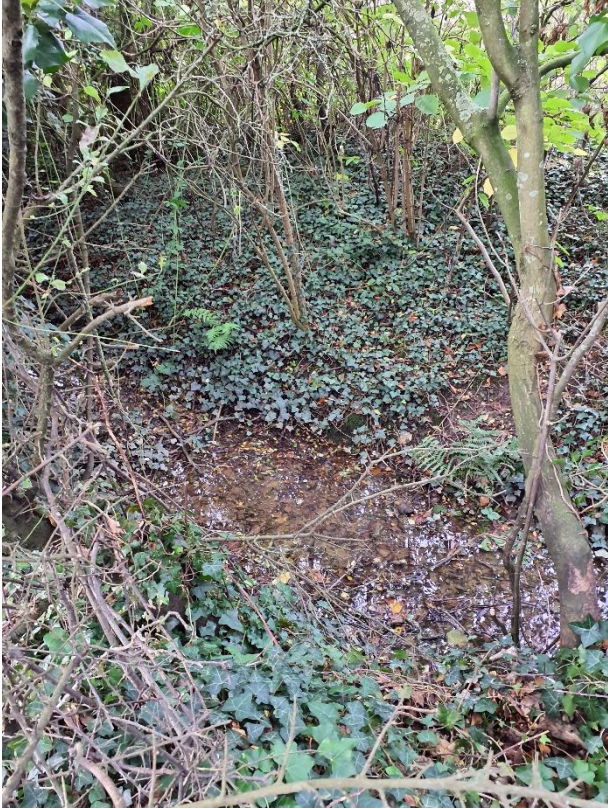
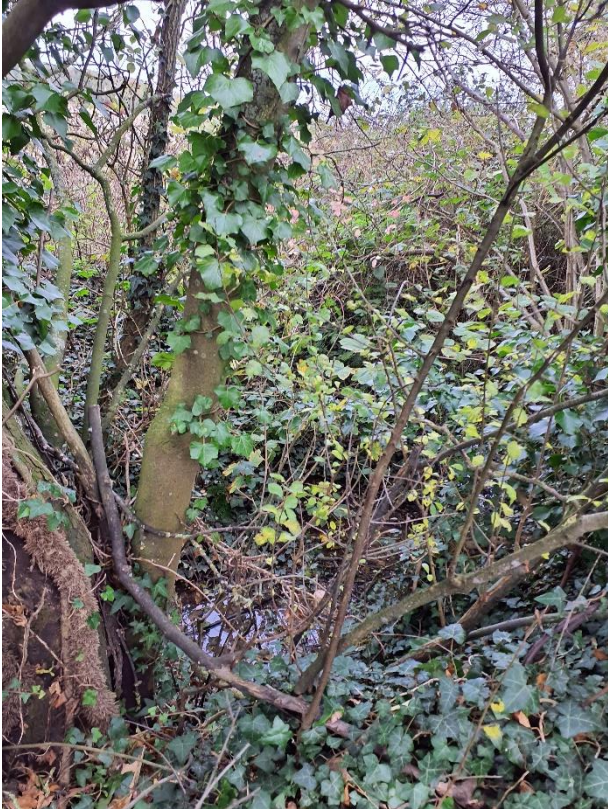
Parameter	Description
Grid Reference	TA 03618 35590
Flow Conditions	Flow appeared to be stagnant, although the reach was heavily obscured by vegetation.
Channel Form, Soils and Substrates	The watercourse is an artificial drainage channel. The surrounding land use on both banks is characterised by scrubby riparian woodland. The observed substrate material was silt, and the bank material was sandy. The watercourse has a bankfull width and depth of 1.5 m and 0.5 m respectively, and a wetted width and depth of 0.8 m and 0.05 m.
Floodplain Connectivity	There is no connectivity with the floodplain.
In Channel / Riparian Vegetation	There was extensive in-channel vegetation observed. Dense herbaceous vegetation and shrubs were observed on both banks, and there was high canopy cover of >70%.
Modifications / Structures / Pollution	There were no in-channel modifications / structures observed.

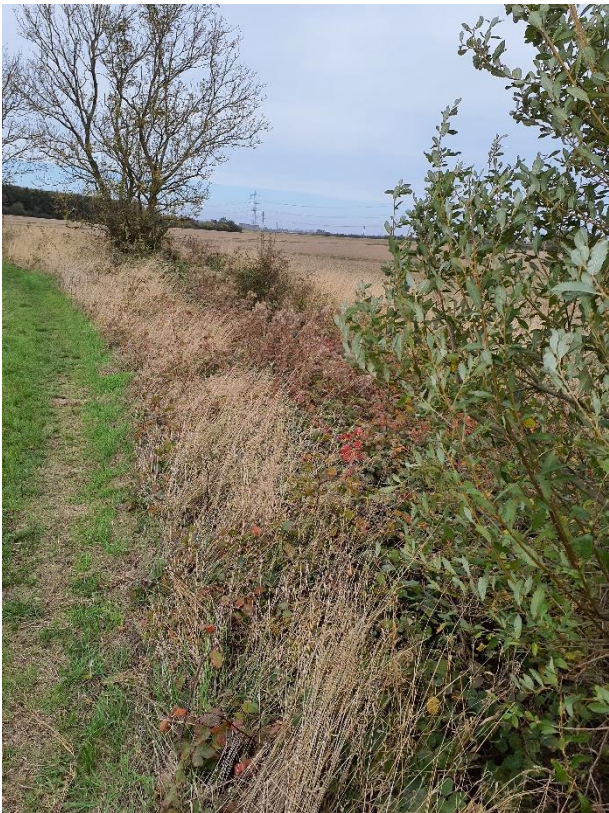
Parameter	Description
Grid Reference	TA 03572 35356
Overview	<p>A fourth location south of Birkhill Wood (D) was recorded approximately 0.2 km upstream of South of Birkhill Wood C. The features observed at South of Birkhill Wood D were similar to that described in Table 21.2-18 and are not described further.</p>

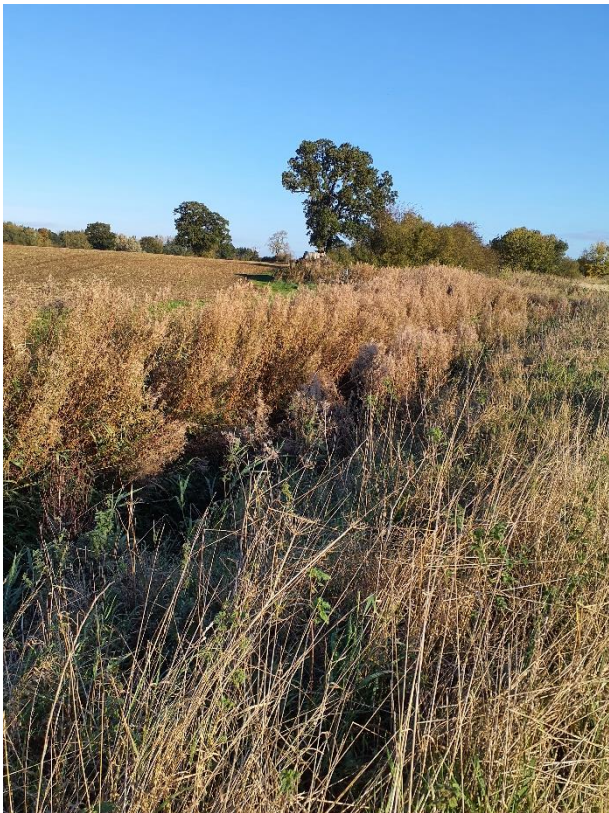
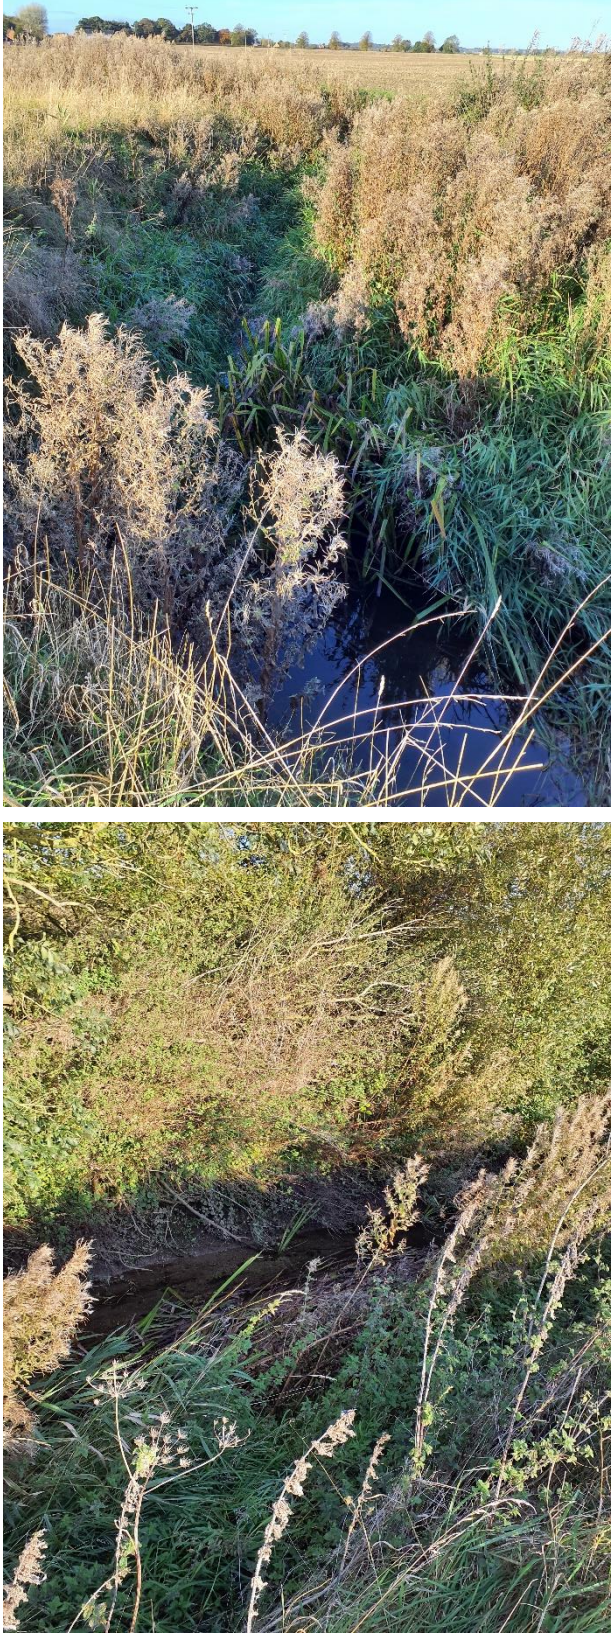
Parameter	Description
Grid Reference	TA 01836 45714
Overview	<p>Scorborough Beck flows in a deep, incised channel. The adjacent land use on both banks was arable. Due to thick vegetation obscuring the channel at all but one location, observations were made at this single accessible point.</p>

Parameter	Description
Grid Reference	TA 01836 45714
Flow Conditions	There was little perceptible flow in the reach.
Channel Form, Soils and Substrates	Fine gravel substrate material was observed in one location and the bank material was silt. There were some signs of fluvial erosion observed on the left bank. The watercourse has a bankfull width and depth of 4.5 m and 3 m respectively, and a wetted width and depth of 2 m and 0.2 m.
Floodplain Connectivity	There is no connectivity with the floodplain.
In Channel / Riparian Vegetation	Extensive in-channel grasses and herbaceous vegetation were observed. Both banks were vegetated with dense herbaceous / scrubby vegetation.
Modifications / Structures / Pollution	There were no in-channel modifications / structures observed at Scarborough Beck.

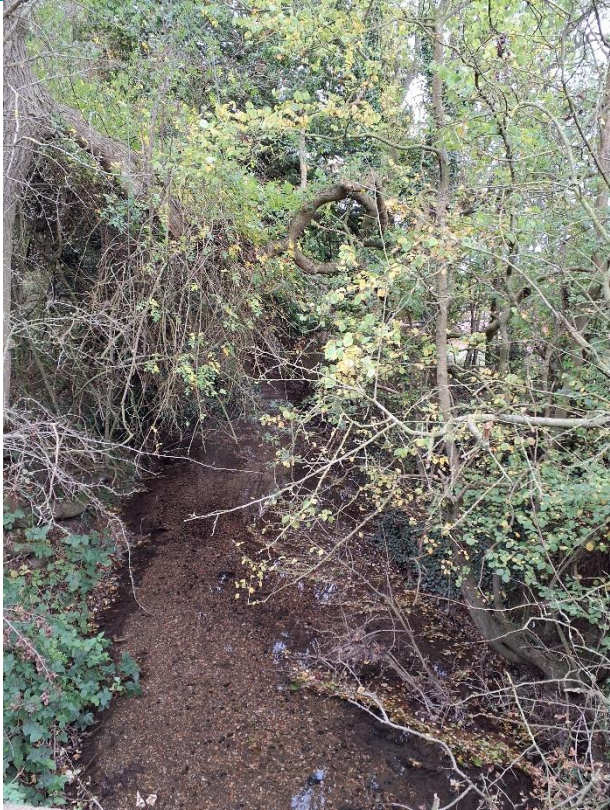
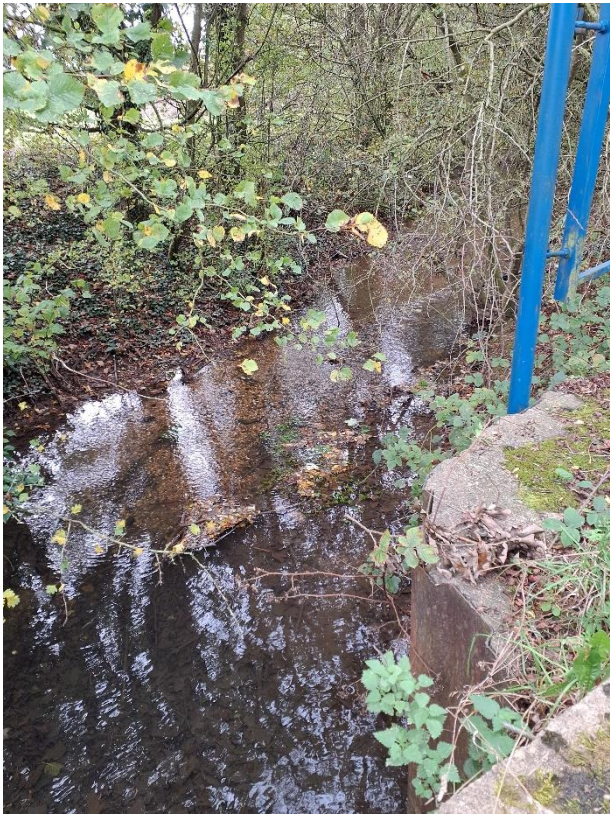
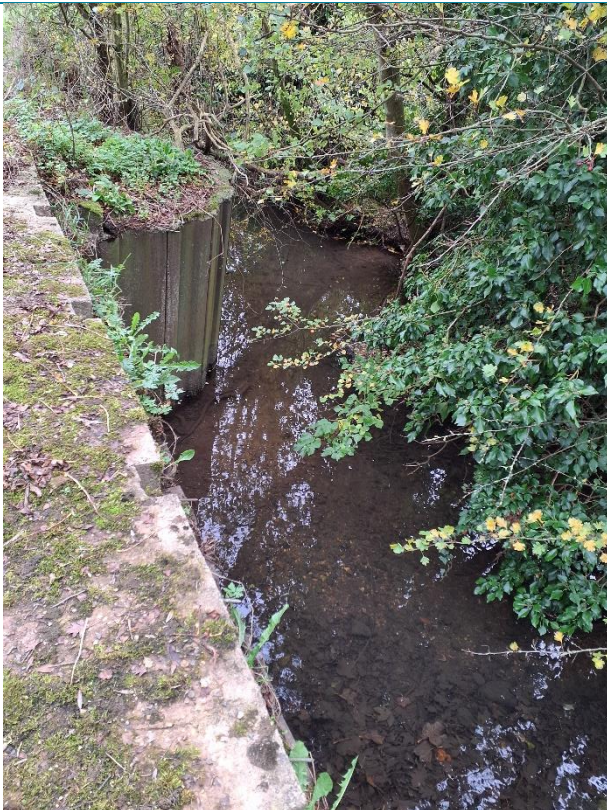
Parameter	Description
Grid Reference	TA 00210 45324
Overview	Bealey's Beck A is a gravel-bed watercourse with a pool-riffle flow sequence. At the observed reach, bank protection was in place for a bridge crossing.

Flow Conditions	Riffles and pool were observed at Bealey's Beck.
Channel Form, Soils and Substrates	The watercourse is narrow with a mixture of woodland and herbaceous vegetation on the banks. The substrate and bank materials are fine gravels and sand, respectively. Erosion in the form of toe undercutting was observed at one location near a bridge. The watercourse has a bankfull width and depth of 5 m and 2.5 m respectively, and a wetted width and depth of 3 m and 0.15 m.
Floodplain Connectivity	There is limited connectivity to the floodplain.
In Channel / Riparian Vegetation	In-channel herbaceous vegetation was present at Bealey's Beck A. Herbaceous vegetation and woodland were also observed on the banks. Due to the wooded surroundings, canopy cover was high (>70%).
Modifications / Structures / Pollution	Sheet pile bank protection and bridge were observed.

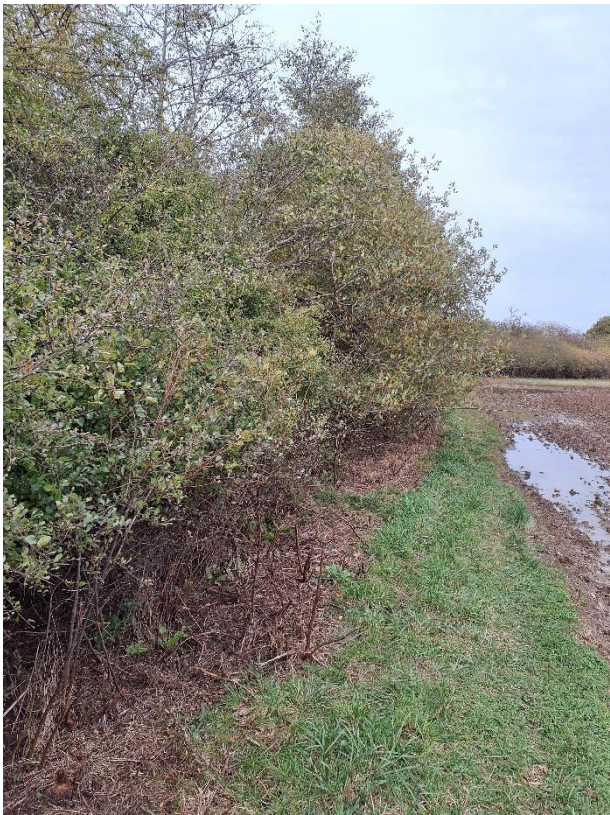
Parameter	Description
Grid Reference	TA 00395 45435
Overview	<p>A second reach along Bealey's Beck was visited approximately 0.3 km downstream of the location recorded in Table 21.2-26. Here, Bealey's Beck was obscured by thick vegetation and no observations of the channel were made.</p>

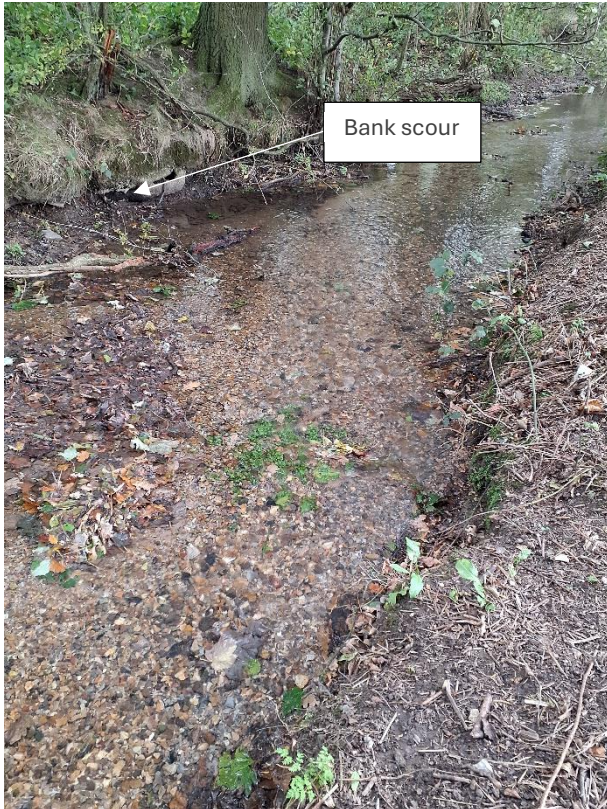
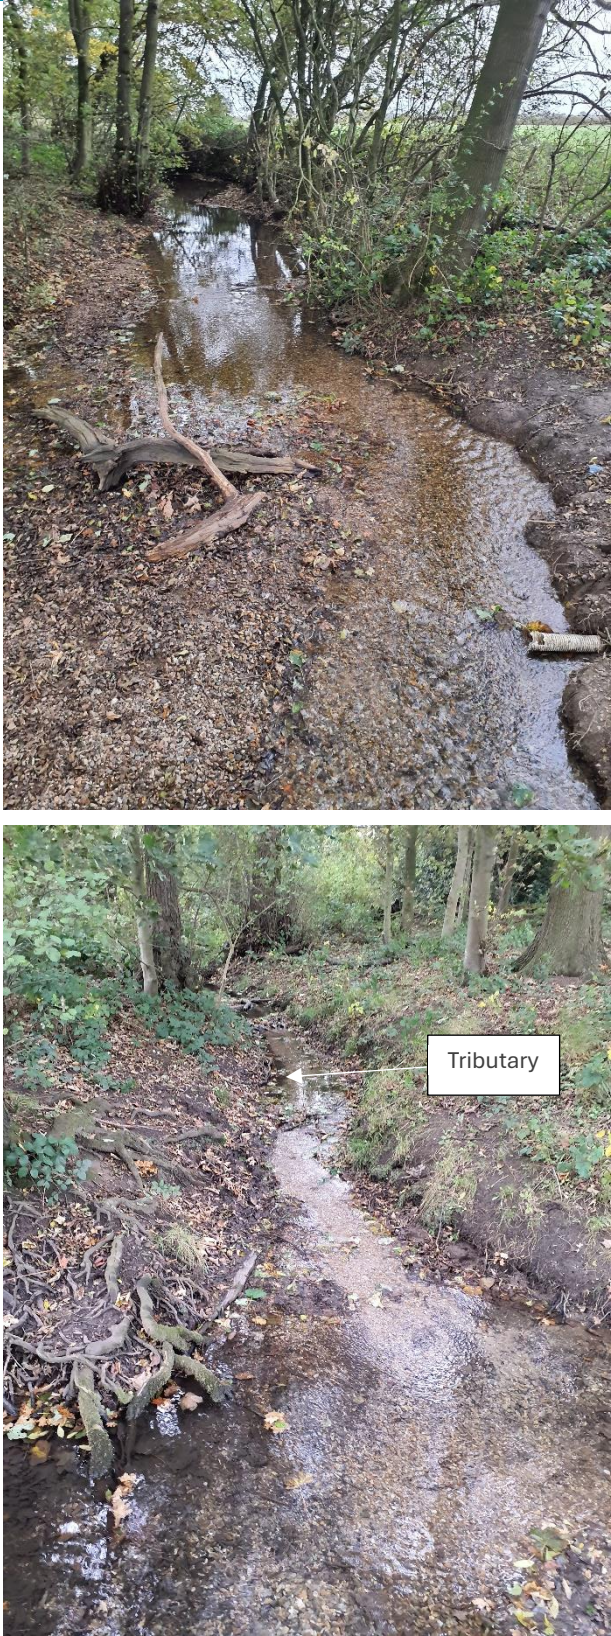
Parameter	Description
Grid Reference	TA 00141 45376
Overview	<p>A third reach along Bealey's Beck was recorded approximately 0.1 km upstream of the location recorded in Table 21.2-26. Here, Bealey's Beck was observed as a fine gravel bed reach, with pool-riffle flow types and some in-channel large woody material present. There was also a small tributary that joined the channel 0.01 km upstream. Bank scour was observed at one location along the left bank and a small pipe outlet of the left bank. Overall, the reach is very similar to that described in Table 21.2-26 and is not discussed further.</p>

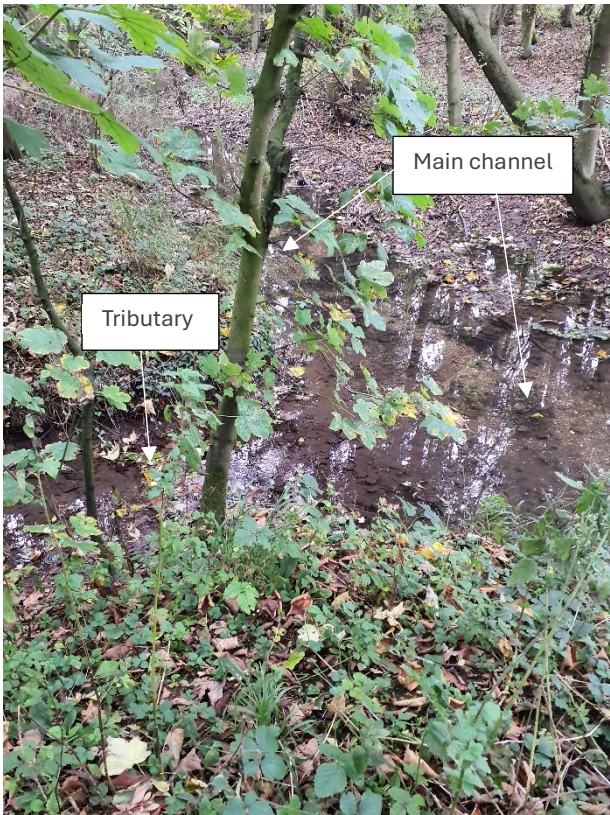
Parameter	Description
Grid Reference	SE 99927 45395
Overview	<p>A fourth reach along Bealey's Beck was observed approximately 0.4 km upstream of the location recorded in Table 21.2-26. Here, Bealey's Beck was observed as a fine gravel and sand bed reach, dominated by riffle and pool flow types. A tributary joined the channel at this observed reach. Overall, the reach is very similar to that described in Table 21.2-26 and is not discussed further.</p>

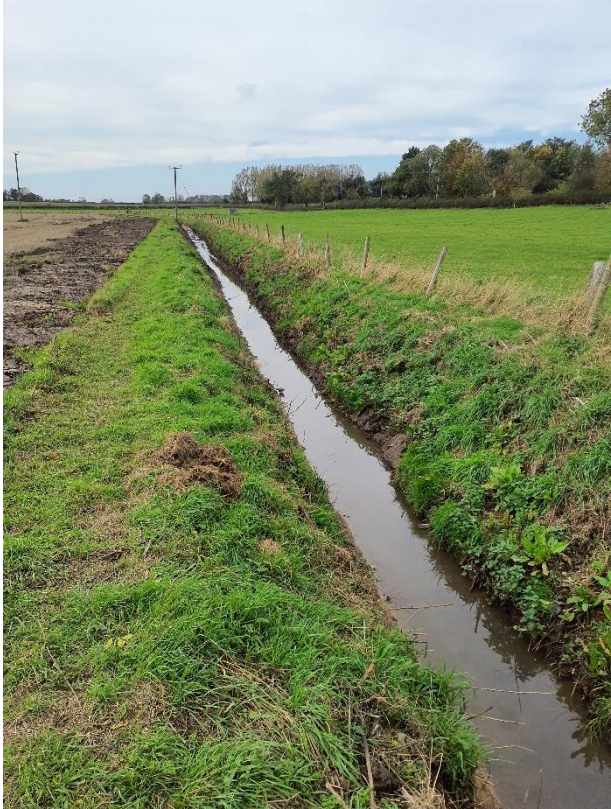
Parameter	Description
Grid Reference	TA 00190 42948
Overview	<p>North Drain A is an artificial drainage channel with a culvert running below Miles Lane Road. Land use is rough pasture on the right bank and arable on the left bank. The channel showed signs of recent excavation / dredging works.</p>

Parameter	Description
Grid Reference	TA 00190 42948
Flow Conditions	Natural flow types were not observed due to recent channel works.
Channel Form, Soils and Substrates	The watercourse is an artificial drainage channel of uniform width. The substrate and bank materials are silt and the bank toe was bare from recent dredging. The watercourse has a bankfull width and depth of 1.5 m and 1 m respectively, and a wetted width and depth of 0.8 m and 0.02 m.
Floodplain Connectivity	There is no connectivity with the floodplain.
In Channel / Riparian Vegetation	There was no in-channel vegetation observed due to the recent dredging / excavation activity. Both banks were vegetated by grasses. There is no diversity in riparian vegetation on the floodplains due to arable land use.
Modifications / Structures / Pollution	One culvert was observed at the North Drain where the channel passes beneath the Miles Lane Road. The channel showed signs of recent dredging / excavation.
